City Community Facilities

2019 Building Report

October 28, 2019

City of Lloydminster Building Committee

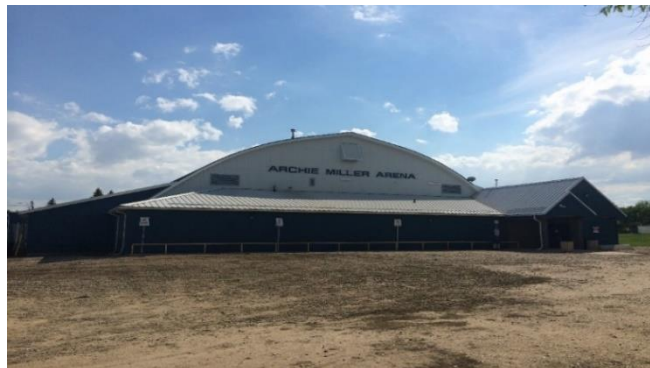
Archie Miller Arena

Building Condition: Marginal to Poor

ACI Architects Plant Assessment evaluation shows the ice plant in good repair and is operating well. Although it is in good condition, it is recommended that the ice plant be changed to a suitable alternate refrigeration system. It is currently using R22, which is no longer an allowable refrigerant and should be replaced with an alternate (ammonia system – R171). The change out will necessitate new compressors, heat exchangers, controls, safety alarms and ventilation systems, etc.

2015 Building assessment showed that structurally, the building presents no significant defects. A further, more detailed examination of site drainage is recommended to rectify reported ground water issues possibly due to site grading. Other capital expenses required if the ice plant is replaced, including a capital upgrade to concrete flooring.

1. Due to significant capital expenditures required for a new ice plant, Administration is recommending await the results from the pool/arena feasibility study that is underway before capital upgrades are completed within the facility.

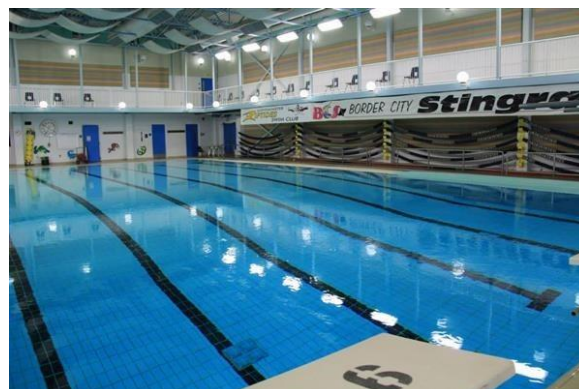
BioClean Aquatic Centre (B.A.C)

Building Condition: Good

ACI Architects conducted a building assessment in 2019. B.A.C. continues to serve the community needs relatively well. The following were noted:

- In the near future the wood siding will require replacement.
- Tile flooring is continually being repaired (which may indicate a problem).
- Steel structural members – continued maintenance required to stay ahead of corrosion.

1. Replacement/repairs to the heat exchangers (in the amount of \$500,000) included in the 2020 Capital Budget.
2. Administration is in the initial phases of conducting a feasibility study. If the feasibility study recommends a new aquatic facility, public engagement will be sought as part of the process.

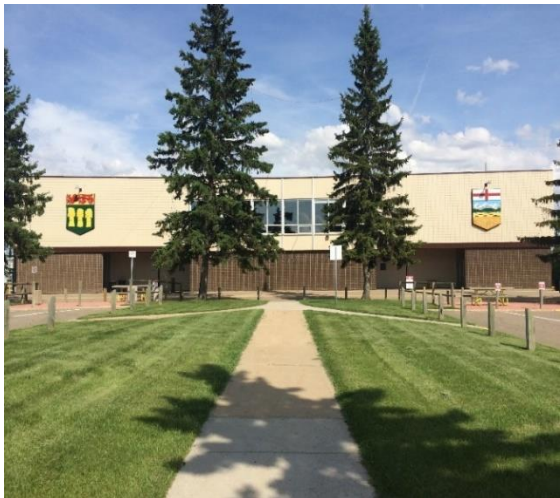
<p>Centennial Civic Centre Constructed: 1965</p> <p>Floor Area: 56,813 sq. ft</p> <p>Building Condition: End of Life</p> <p>Estimated costs to maintain/operate current facility:</p> <p>0 – 5-year costs: \$6,975,000 5 – 10-year costs: \$350,000 10+ year costs: \$0.00</p> <p>Anticipated remaining useable life: 2 to 4 years</p>

<p>ACI Architects and Read Jones Christoffersen Engineers conducted reviews of the facility in 2019. The building has been well maintained and does have newer renovated areas, however, the Centennial Civic Centre is approaching the end of its serviceable lifespan.</p> <p>Summary of Challenges:</p> <ul style="list-style-type: none"> ▪ Limited amount of viable use remaining in building. ▪ Value of renovating versus the value of the building. ▪ Significantly high costs to make necessary repairs which include: <ul style="list-style-type: none"> ○ ice plant room (address deficiencies) ○ dead-end corridors ○ significant capital upgrades required within the next 2 to 8 years ○ drainage of building ○ National Building Code and Fire Safety Code would need to be addressed in renovations.

<p>Recommendation:</p> <ol style="list-style-type: none"> 1. Administration is in the initial phases of conducting a feasibility study for a new pool and arena. Monies for design for the construction of a new facility to replace the Centennial Civic Centre are included within the 2020 Capital Budget with anticipated construction of a new facility in the next two to three years. Public engagement would become part of the process before moving forward with building a new facility. 2. If the City is looking to continue operations of the CCC and not move forward with a new arena, a new ice plant would need to be installed on the outside of the facility at an estimated cost of \$1.2M to \$1.5M. However, these costs do not take into consideration any structural issues that may arise during construction due to the age of the facility.

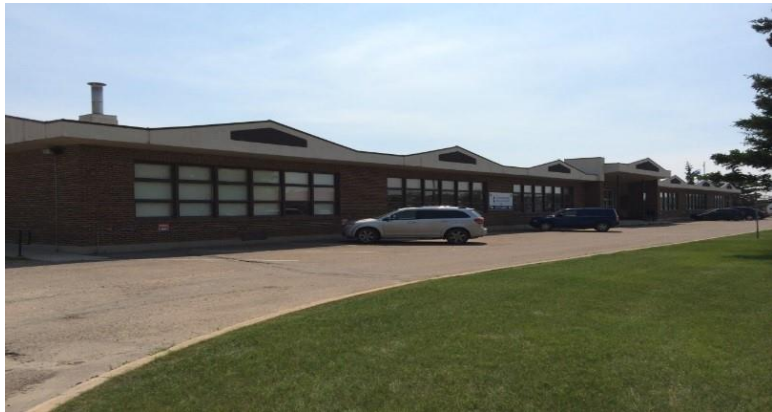
<p>Community Services Building Constructed: 1951</p> <p>Floor Area: 14,838 sq. ft</p> <p>Building Condition: End of Life</p> <p>Estimated costs to operate/maintain current facility: 0 – 5-year costs: \$0.00</p> <p>Estimated cost to demolish facility: \$250,000 to \$350,000 (included in 2020 Capital Budget)</p> <p>Land Value: \$1.2M (2018 appraisal)</p> <p>Anticipated remaining useable life: 0 years</p>

<p>S2 Architects completed a building assessment in 2018. The report highlighted several areas where there were significant deficiencies:</p> <ul style="list-style-type: none"> ▪ National Building Code deficiencies: <ul style="list-style-type: none"> ○ no sprinkler system; ○ no fire alarm; ○ insufficient fire rating in wall and roof assemblies; ○ exterior windows are original and require replacing; ▪ Access road and parking reconstruction required, and the storm system requires replacement; ▪ In the crawlspace there is an ongoing water infiltration problem that would require the construction of a weeping tile system. ▪ Combined cost of rehabilitating is significant. <p>Tenants have been given notice to vacate the building at the end of June 2020; building to be vacant July 1, 2020.</p>

<p>Recommendation:</p> <ol style="list-style-type: none"> 1. Demolition of the facility in 2020. Costs for demolition are included in the 2020 Capital Budget. 2. Ensure lease revenues are adjusted within the 2020 budget. 3. Future considerations: <ol style="list-style-type: none"> a) Resale land for potential commercial purposes; or b) Utilize land for municipal infrastructure.

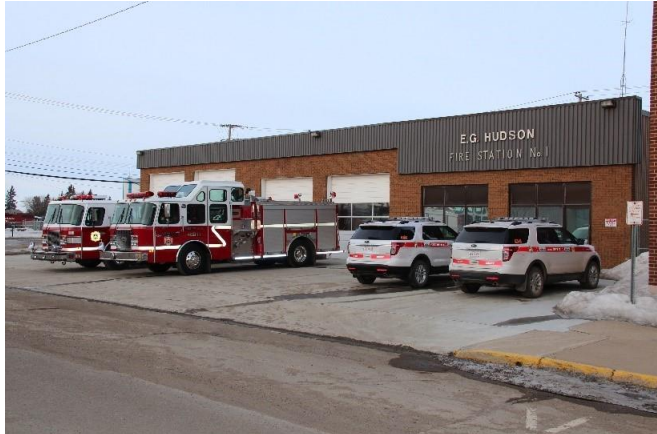
<p>Firehall #1 Constructed: 1940's, 1959, 1964, 1977, and 1992</p> <p>Floor Area: 7,836 sq. ft</p> <p>Building Condition: End of Life</p> <p>Estimated costs to maintain/operate current facility: 0 – 5-year costs: \$0.00 5 – 10-year costs: \$0.00 10+ year costs: \$0.00</p> <p>Estimated replacement costs: \$10M+ (New building)</p> <p>Anticipated remaining useable life: 0 to 1 year</p>

<p>In 2019 S2 Architects carried out an Infrastructure Needs Assessment and Engineering Study. This study identified the spatial requirements for operating a full-time fire department and confirmed that most of the original building could not be adapted to meet these needs.</p> <p>There was the potential for reusing the 1991 expansion to the north, however, the report highlighted a limitation to site as it has an easement through the middle, leaving two options:</p> <ol style="list-style-type: none"> 1. Remove the easement at a significant cost which involves the relocation of electrical and communication routes to the perimeter of the site; or 2. Identify an alternate site for the facility.

<p>Recommendation:</p> <ol style="list-style-type: none"> 1. Administration to conduct an internal review/evaluation for a potential viable site for a new Firehall. 2. The costs associated with the site design/implementation for a new Firehall be included in the 2020 Capital Budget.

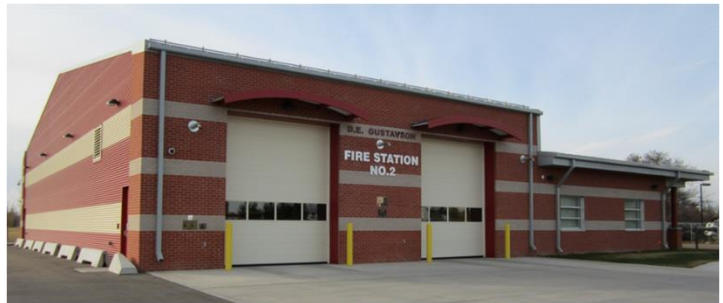
Firehall #2

Building Condition: Good

Overall the building is in good condition. Operationally the building has a number of deficiencies including no sleeping accomodation, no fitness room and limited office space. These will need to be addressed in the next 5 to 10 years with an addition to the facility.

1. Continue with regular maintenance and capital upgrades as required.

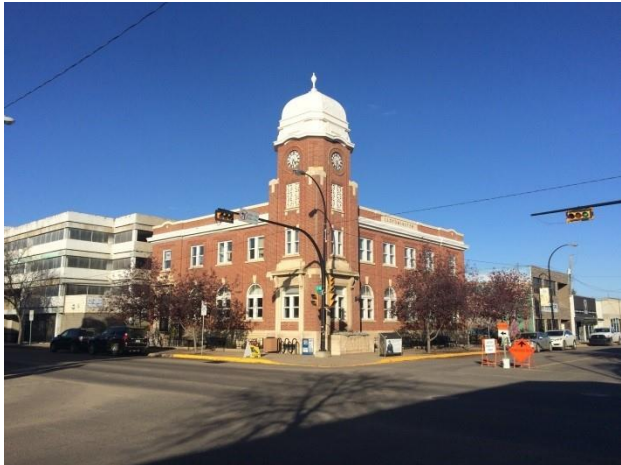
<p>Heritage Building Constructed: 1931</p> <p>Floor Area: 8000 sq. feet (3 floors)</p> <p>Building Condition: End of Life</p> <p>Estimated costs to renovate: 0 – 5-year costs: \$2.8M to \$3M</p> <p>Anticipated proceeds from sale of facility: \$450,000</p> <p>Anticipated remaining useable life: 0 years to the City of Lloydminster **</p>

<p>The designated Heritage Building was last renovated in 1981. Many of the building’s systems are now beyond their serviceable life.</p> <p><u>Summary of Challenges:</u></p> <ul style="list-style-type: none"> ▪ AC system failure that is not repairable; must be replaced. ▪ Doesn’t meet National Building Codes or Fire Safety Codes: <ul style="list-style-type: none"> ○ No fire alarm or sprinkler system ○ Insufficient fire rating in the wall and floor assemblies ▪ Culturally significant to the City of Lloydminster – Heritage Designation. <p>Due to HVAC issues and the City no longer being able to provide adequately conditioned air, the building no longer has tenants.</p>

** Heritage Building is structurally sound and with building rehabilitation it is expected to have a 20+ year life span.

<p>Recommendation:</p> <ol style="list-style-type: none"> 1. List building for sale on Market.

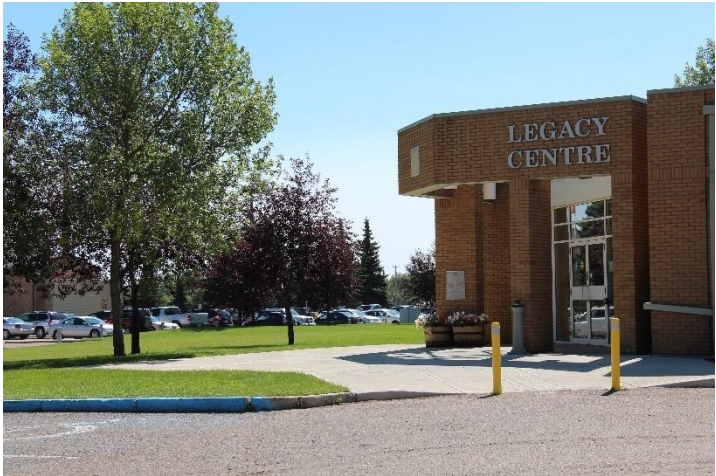
<p>Legacy Centre Constructed: 1990; Expansion 2012</p> <p>Floor Area: 11,191 sq. ft</p> <p>Building Condition: Good</p> <p>Estimated costs to maintain/operate current facility:</p> <p>0 – 5-year costs: \$300,000 5 – 10-year costs: \$0.00 10+ year costs: \$0.00</p> <p>Anticipated remaining useable life: 20+ years</p>

<p>Overall the building is in good condition. The Legacy Centre was expanded in 2012 with a new kitchen and serving area. In 2018 the washrooms were rehabilitated. HVAC system upgrades are planned for 2020.</p> <p><u>Overview:</u></p> <ul style="list-style-type: none"> ▪ Renovations and upgrades have occurred in recent years. ▪ HVAC repairs in the amount of \$300,000 are required. 	
<p>Recommendation:</p> <ol style="list-style-type: none"> 1. Replacement/repairs to the HVAC unit is required; estimated costs of \$300,000 included in the 2020 Capital Budget. 2. Continued regular maintenance of the facility.

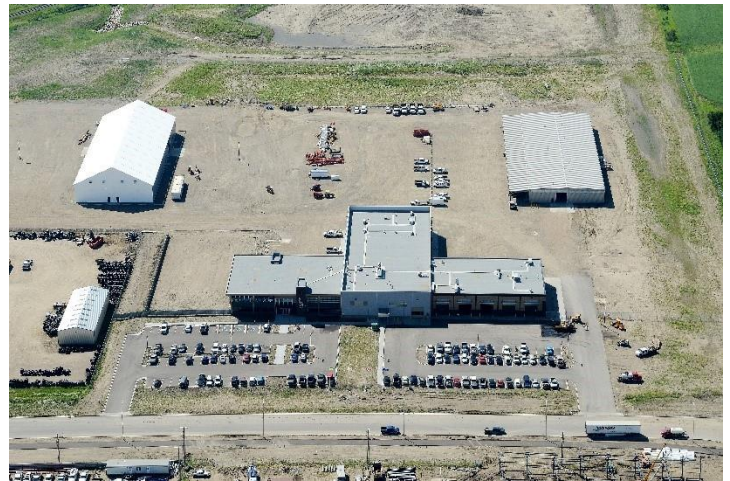
Building Condition: Good

The Operations Centre is one of the City’s newer facilities and does not require any major upgrades to the existing infrastructure in the near future. However, as the City grows, and the fleet of equipment increases, there will be requirements in the next five (5) to ten (10) years to add to the warm storage capacity. This will likely be a similar building to the existing warm storage building.

1. Continue regular on-going maintenance and routine capital maintenance as required.

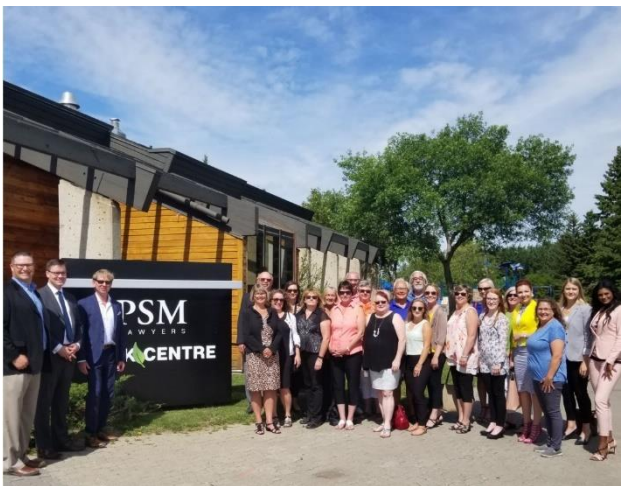
<p>PSM Building (Bud Miller All Seasons Park) Constructed: 1989</p> <p>Floor Area: 8,347 sq. ft</p> <p>Building Condition: Marginal to Poor</p> <p>Estimated costs to maintain/operate current facility: 0 – 5-year costs: \$\$530,000 5 – 10-year costs: \$0.00 10+ year costs: \$0.00</p> <p>Anticipated remaining useable life: 20+ years **</p>

<p>The PSM Park Centre building’s systems and finishes indicate signs of reaching the end of their serviceable life. There has been some rehabilitation with the siding being replaced over the last two years and the furnaces replaced in 2014.</p> <p><u>Summary of Challenges:</u></p> <ul style="list-style-type: none"> ▪ Building is under-utilized. ▪ Requires updates/renovations - Interior finishes are deteriorating with signs of excessive wear and damage. ▪ Concession area is not in operational condition. ▪ Washrooms require upgrades. ▪ Consider revamping the interior – either to accommodate office space and/or programming space.

** The Building envelope is structurally sound and with interior rehabilitation it is anticipated to have a 20+ year life expectancy.

<p>Recommendation:</p> <ol style="list-style-type: none"> 1. Architect design for a capital interior design revamp that better meets the needs of the City in the amount of \$25,000 to \$30,000 is included in the 2020 Capital Budget. 2. Estimated construction costs in the amount of \$500,000 to be considered in future capital budgets within the next five years.

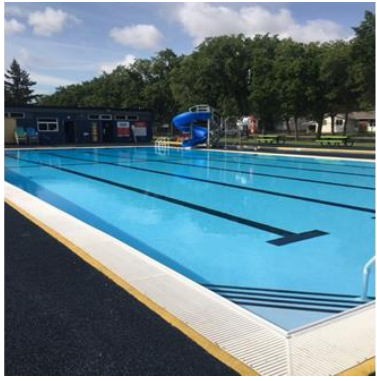
<p>Outdoor Pool Constructed: 1964</p> <p>Building Condition: Good</p> <p>Estimated costs to maintain/operate current facility: 0 – 5-year costs: \$15,000 5 – 10-year costs: \$70,000 10+ year costs: \$10,000</p> <p>Anticipated remaining useable life: 10+ years</p>

<p>A review was completed by ACI architects in 2019.</p> <p><u>Overview:</u> Facility is in good condition, with some noted shortcomings that can be addressed. The building has been well maintained and should serve the community for years to come.</p>	
<p>Recommendation:</p> <ol style="list-style-type: none"> 1. Continue regular maintenance and required capital upgrades as required. 2. Continuous monitoring of the facility.

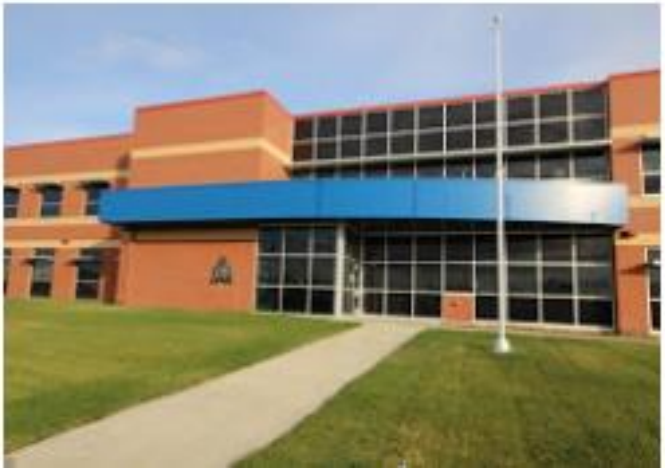
<p>RCMP Building Constructed: 2014</p> <p>Floor Area: 60,000 sq. ft</p> <p>Building Condition: Good</p> <p>Estimated costs to maintain/operate current facility: 0 – 5-year costs: \$120,000 to \$1.5M 5 – 10-year costs: \$0.00 10+ year costs: \$0.00</p> <p>Anticipated remaining useable life: 20+ years</p>

<p>The RCMP Building is one of the newer buildings in the City and is in very good condition. On the second floor there is space that is available for future expansion as it is not developed. The RCMP are already finding that they are outgrowing the space and are looking to develop the second floor to relocate some of their operations.</p> <p><u>Overview:</u></p> <ul style="list-style-type: none"> ▪ Consider expansion of RCMP Building. 	
<p>Recommendation:</p> <ol style="list-style-type: none"> 1. Continue with regular on-going maintenance. 2. Design plan for the expansion of the RCMP included in the 2020 Capital Budget (potential costs for expansion in the amount of \$1.5M to be considered for the 2021 Capital Budget).

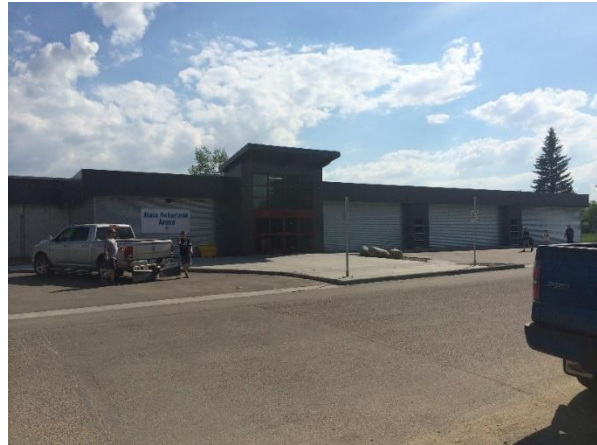
Russ Robertson

Building Condition: Good

Building Assessments were conducted in 2013 and an ice plant assessment was completed in 2019 by ACI Architects (2019). The Review indicated that the ice plant appears to be in generally good condition.

- Recent renovations completed; no immediate concerns to address.
- Building assessment is required; numbers indicate to maintain/operate current facility are for the ice plant room only.

1. Continue with regular building maintenance.
2. Administration is bringing forward a recommendation that a full building assessment be conducted, which is included in the 2020 Capital Budget.

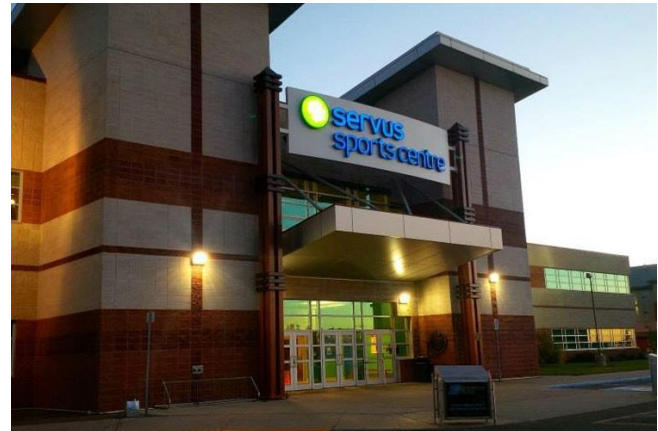
Servus Sports Centre

Building Condition: Good

ACI Architects completed an assessment of the ice plant in 2019.

- Parking surface repairs required.
- General repairs to wall penetrations.
- TPO roofing membrane is prone to leaks and replacement of that roofing product is recommended in the coming years.

1. Facility upgrades for the roofing membrane replacement is included in the 2020 Capital Budget.
2. Continued on-going regular maintenance.
