LCSC Visitor Experience Report

Lloydminster Cultural and Science Centre Condition Assessment

Associated Engineering Alberta Ltd. (AE) carried out a visual review and condition assessment of the Lloydminster Cultural and Science Centre on May 8, 2019.

Lloydminster Cultural and Science Centre Condition Assessment (Architecture)

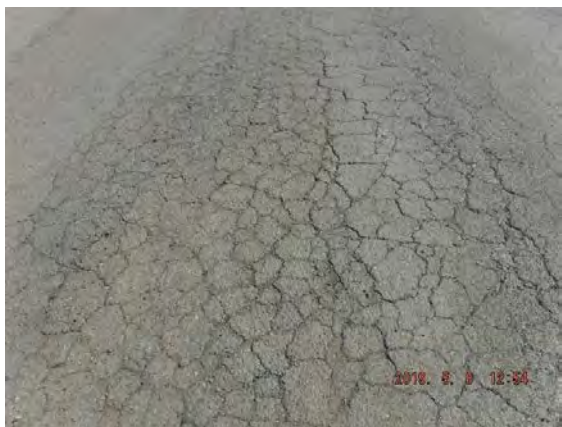
Figure 2-2 Parking Lot: Alligator Cracks

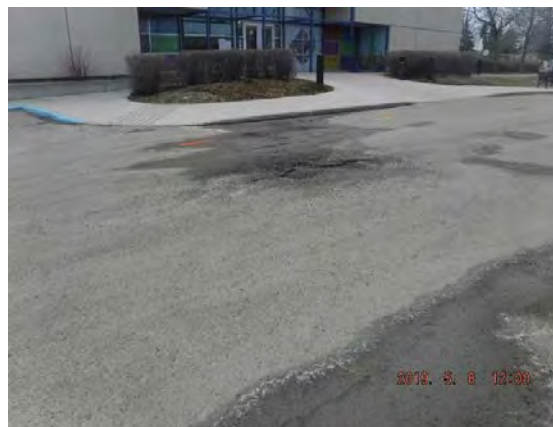
Figure 2-3 Parking Lot: Moisture

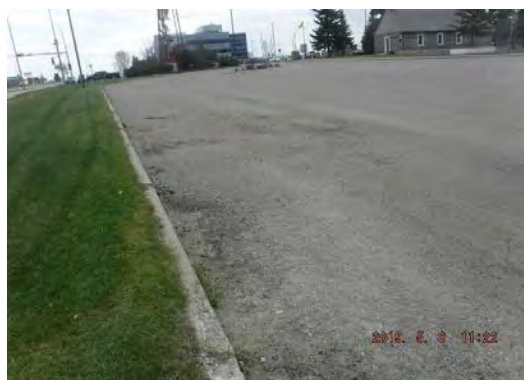
The parking lot has road surface markings which demarcate the parking bays. These markings have faded over time and they are no longer clearly visible as shown below on Figure 2-4.

Figure 2-4 Parking Lot: Faded Road Markings

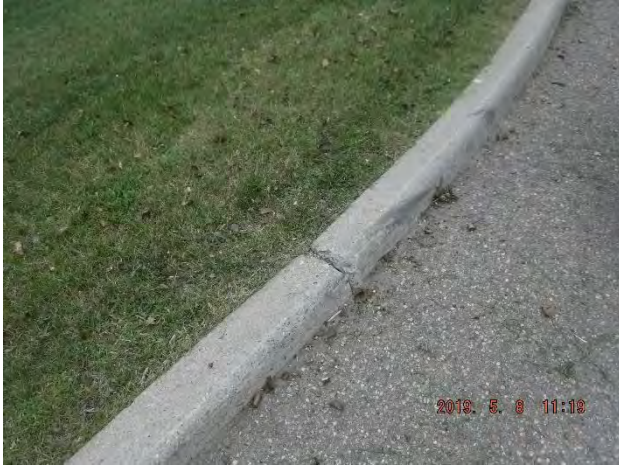
The parking lot is bound by straight face concrete curbs. Based on a visual assessment, the curbs are generally in a good condition, however, some curbs have cracks, and some curbs have chips and some have edge breaks as shown on Figure 2-5 and Figure 2-6.

Figure 2-5 Parking Lot: Curbs with Edge Breaks

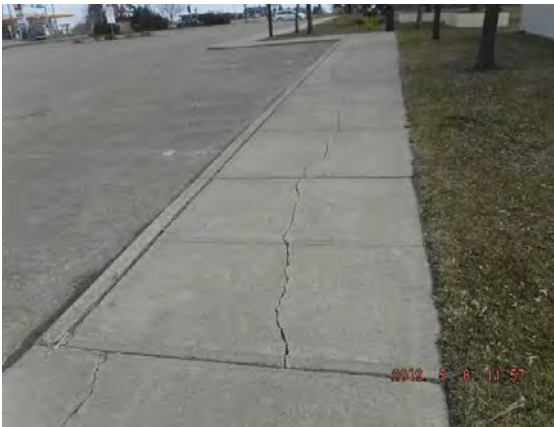
- Insufficient backfill during construction;
- Overloading; and
- Frost heave or soil saturation.

Figure 2-7 Parking Lot: Cracked Walkways

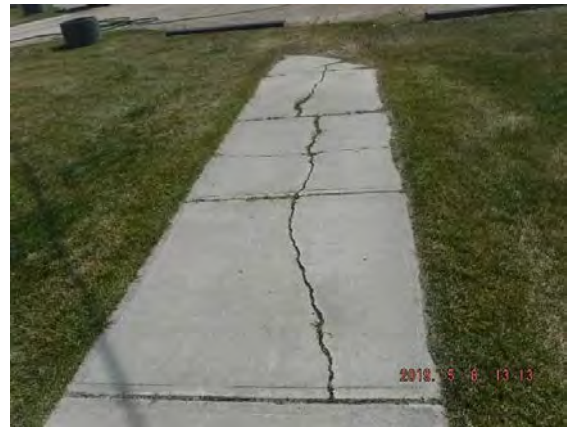
Figure 2-8 Rear Entrance: Cracked Walkways

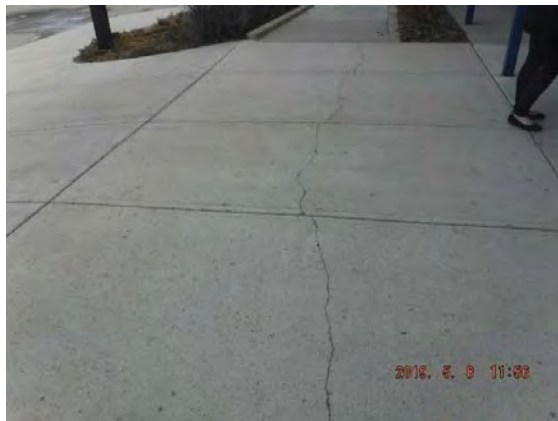
There are cracked concrete pads at the main entrance as shown on Figure 2-9. These cracked concrete pads currently do not pose a tripping hazard.

Figure 2-9 Cracked Concrete Pads

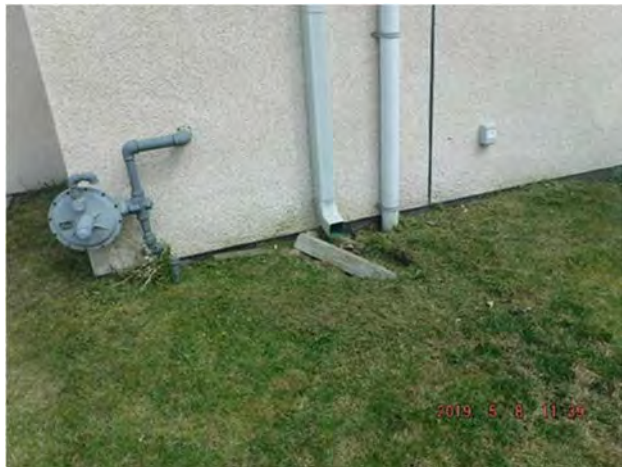
the water, some splash pads are misaligned and some splash pads direct water towards the building. Over time, the water from these downspouts may erode backfilled material surrounding the building. This may create local low points which encourage ponding of water near the building, increasing the likelihood of ingress of water into the building.

Figure 2-14 Misaligned Splashpads

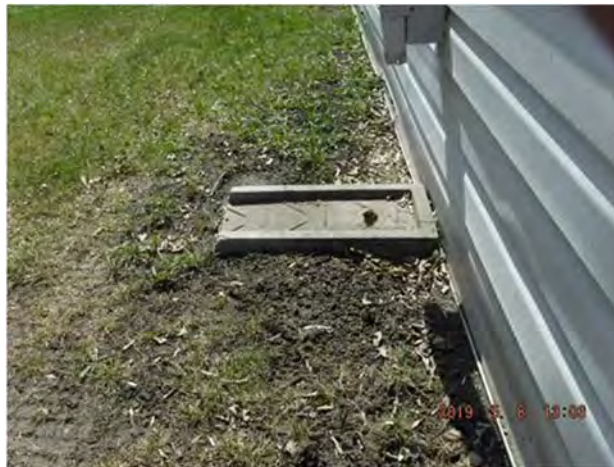
Figure 2-15 Damaged Downspouts

Disc.	Asset	Work Description	Priority	Estimated Cost
Civil	Barr Colony Centre	Install downspouts and splash pads throughout building's exterior	Immediate	\$3,000
Mech.	Barr Colony Centre	Air Handling Unit (AHU-1) system replacement, including ductwork and reheat coils	Immediate	\$200,000
Mech.	Barr Colony Centre	Air Handling Unit (AHU-2) system replacement, including ductwork and reheat coils	Immediate	\$500,000
Mech.	Barr Colony Centre	Whole Boiler system replacement, including system piping in Barr Colony Centre	Immediate	\$400,000
Mech.	Barr Colony Centre	Plan for replacement of Chiller (CH-1) system in Barr Colony Centre	Immediate	\$40,000
Mech.	Barr Colony Centre	Plan for replacement of Chiller (CH-2) system in Barr Colony Centre	Immediate	\$80,000
Elec.	Barr Colony Centre	Replace Main MCC and Switchboard in Barr Colony Centre	Immediate	\$70,000
Elec.	Barr Colony Centre	Replace 120/208V Distribution Panels	Immediate	\$30,000

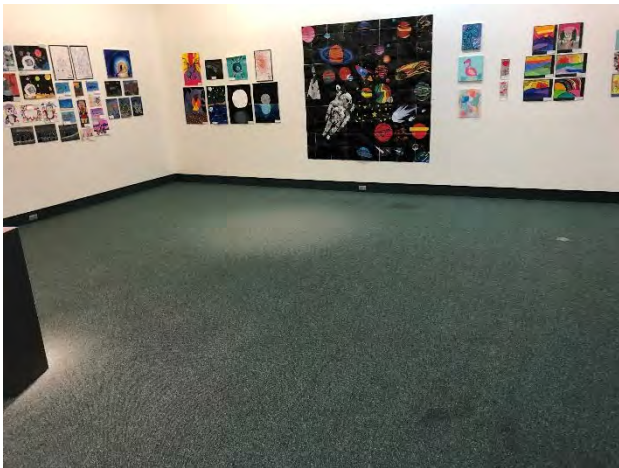
Figure 3-3 Floor Slab in Gallery Three

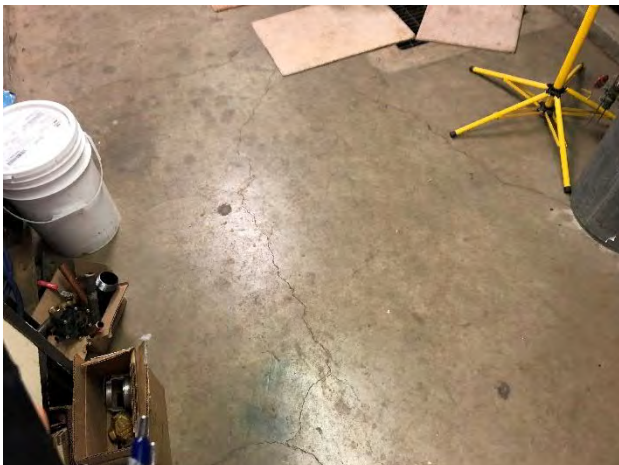
Figure 3-5 Typical Crack in Main Mechanical Room Slab

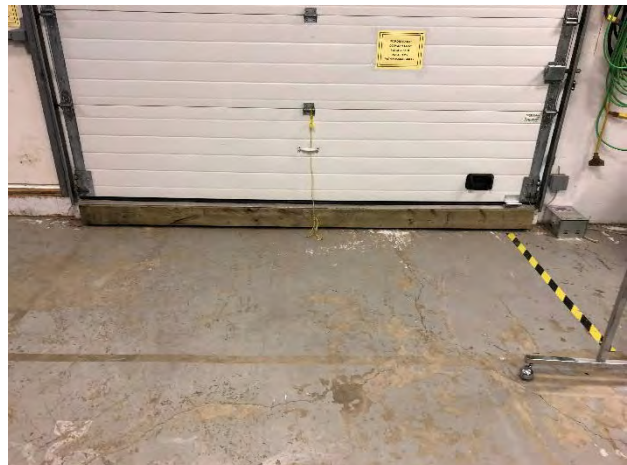
Figure 3-6 Typical Cracking in Richard Larson Slab

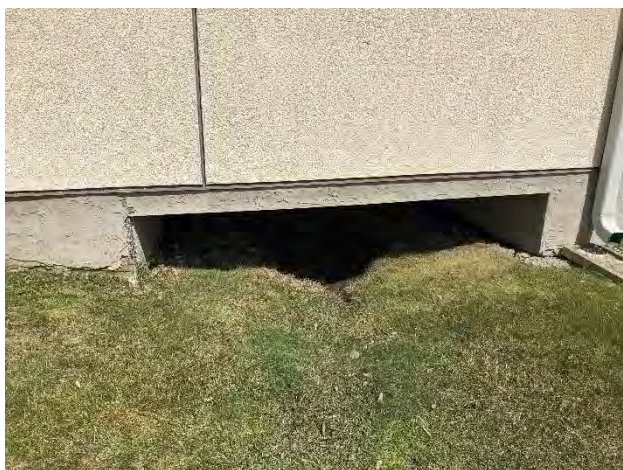
The suspended slab within the Corridor Link spans over an exterior drainage trench. This structure comprises of steel decking and a concrete topping. The top surface was covered by a tile floor finish, and the underside by aluminum soffit; due to restrictive visibility the structural elements could not be directly assessed. No obvious signs of concern were noted.

Figure 3-7 Corridor Link Suspended Slab

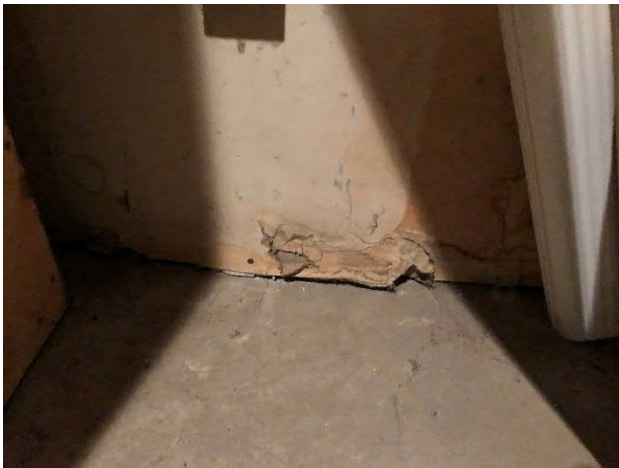
Currently, the extent of mold within the East Wings (Fuchs, Heavy Oil Building and Corridor) are unknown as the 2013 assessment did not perform intrusive testing. These structures have served their expected lives, and with the potential damages and remediation costs of expected mold, it not be feasible to maintain the structures. It is recommended that planning of demolition be considered.

Figure 3-9 Viewing Water Damage in Heavy Oil Mechanical Room

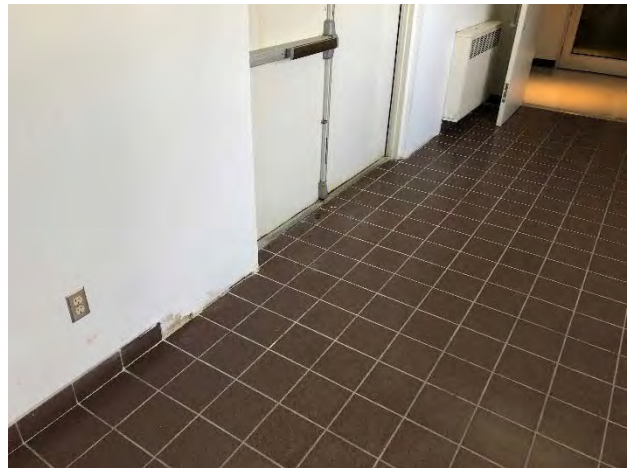
Figure 3-10 Viewing Water Damage to Corridor Link

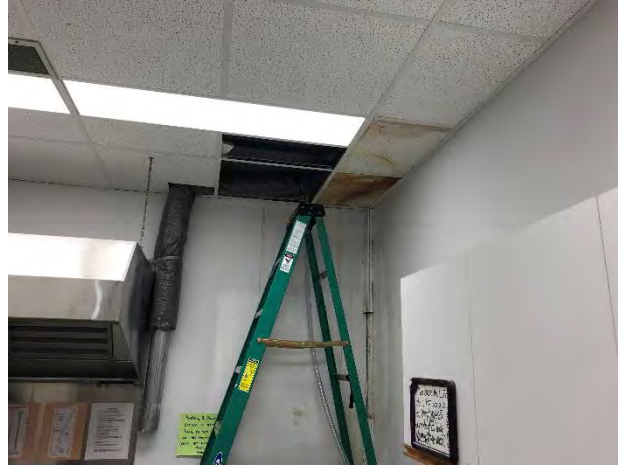
Figure 3-11 Viewing Water Damage in Link

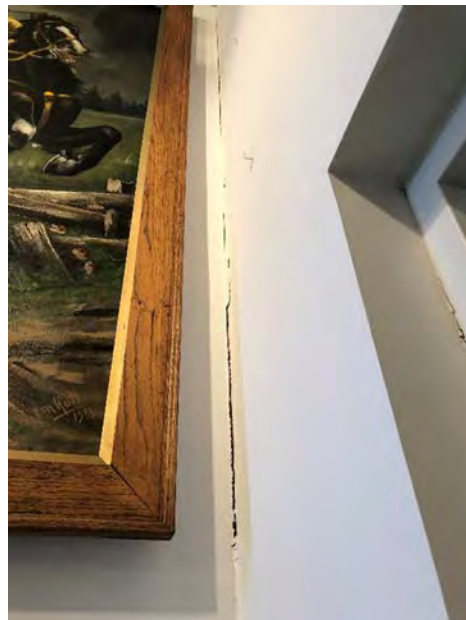
- A crack in the gypsum board finish has developed in the southeast corner of Imhoff Gallery. It was explained by representatives that the crack opens in winter conditions creating a wide gap. No evidence of heaving was identified. It is possible that the gap develops from differential thermal movements from adjoining infill walls at the corner column. It is likely that this is not a structural concern, and more aesthetic. A vertical expansion joint intended for gypsum board could be installed at this location to allow for movement.

Figure 3-12 Viewing Crack in SE Corner of Imhoff Gallery

Disc.	Asset	Work Description	Priority	Estimated Cost
Elec.	Barr Colony Centre	Installation of additional emergency lighting	Immediate	\$10,000
Struc.	Barr Colony Centre	Repair vertical crack in SE corner of Imhoff Gallery with an expansion joint intended for gypsum board finishes	High	\$2,000
Struc.	Barr Colony Centre	Mold remediation of Barr Colony Centre (unknown quantity)	High	\$60,000
Struc.	Barr Colony Centre	Repaint exterior steel framing at Main Entrance	High	\$5,000
Mech.	Barr Colony Centre	Humidification system replacement, including piping	High	\$250,000
Mech.	Barr Colony Centre	Plan for replacement of Exhaust Fan (EF-1)	High	\$8,000
Mech.	Barr Colony Centre	Electric and hot water heaters throughout building	High	\$20,000
Mech.	Barr Colony Centre	Full electronic control upgrade and pneumatic removal throughout entire facility	High	\$200,000
Elec.	Barr Colony Centre	Replace Exterior Receptacles with Weatherproof GFI type for Barr Colony Centre	High	\$3,000

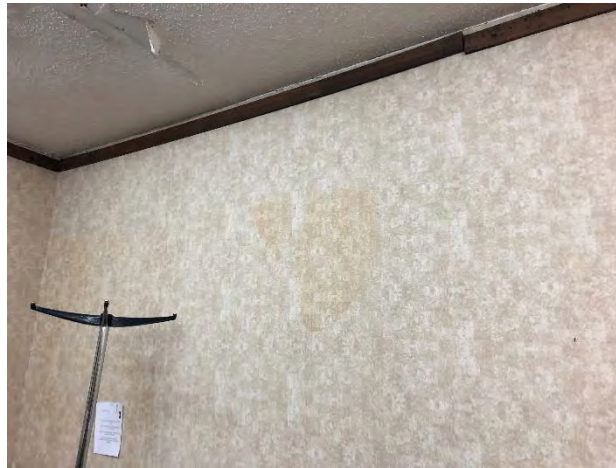
- The walls of Richard Larson Building have been identified in the past to be overloaded. Additional timber framing has been constructed in the building as temporary measures. Water staining was also seen in this area. This

portion of the building is considered to be of low quality construction and at its intended life expectancy of about 40 years. It is recommended that this area be planned for demolition.

Figure 3-13 Water Staining on Richard Larson Wall

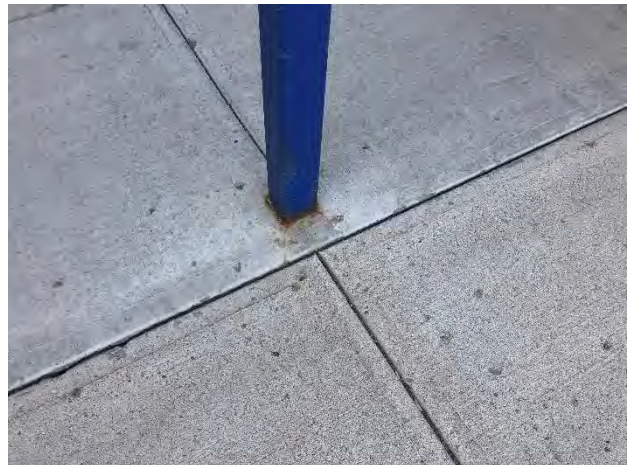
Most of the structural steel framing is hidden within walls. Visible columns were assessed and appeared to be in good condition with one exception; exterior columns of the main entrance have minor surface corrosion. These surfaces shall be prepared and recoated for protection.

Figure 3-15 Viewing Corrosion at Bottom of Exterior Columns

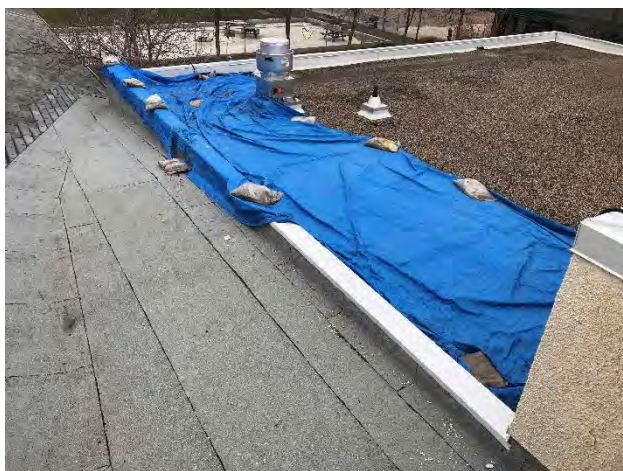
Substantial staining from a roof leak is present in the kitchen area of Main Museum. The roofing above is covered by a polyester tarp as a temporary means of protection. The steel structure appears to be in adequate condition from below, although it should be confirmed during re-roofing time. No other obvious concerns were noted and the systems are considered to be in good condition.

Figure 3-16 Viewing Roof of Kitchen Area

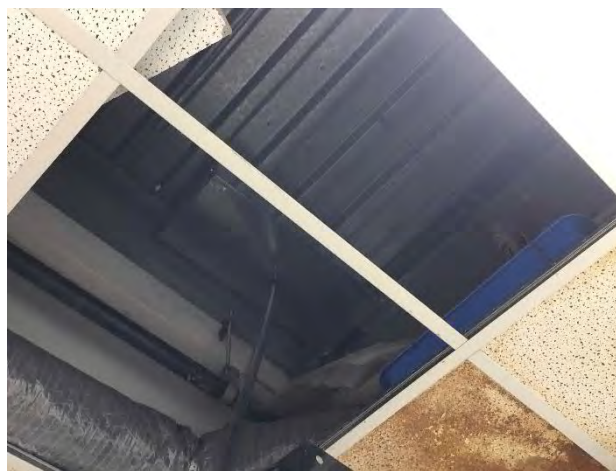
Figure 3-17 Viewing Condition of Roof Structure in Kitchen

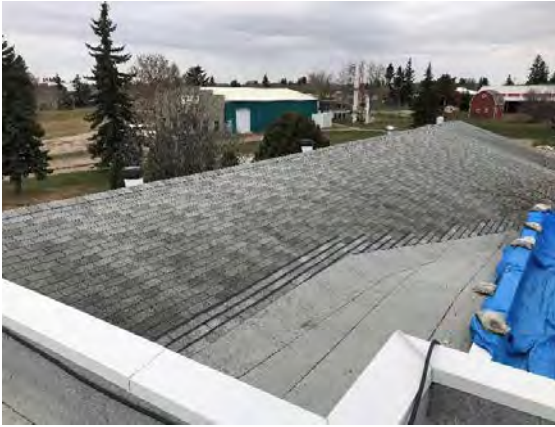
The roofing of the West Wing of Richard Larson Building comprises of oriented strand board (OSB) on timber trusses spaced at 24 inches. While performing roof top assessment considerable deflection was noted in the sheathing. The material also felt to be somewhat soft and spongy, indicating roof sheathing is likely subject to moisture damage, which is also supported by visible staining on much of the interior ceilings. This area is considered to be of low quality construction and has fulfilled its expected life expectancy of 40 years. It is recommended that this area be planned for decommissioning.

Figure 3-18 Viewing Richard Larson Roof

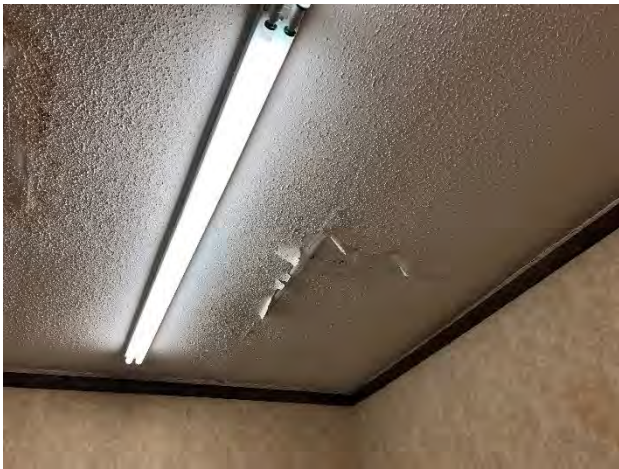
Figure 3-20 Water Damage to Richard Larson Ceiling

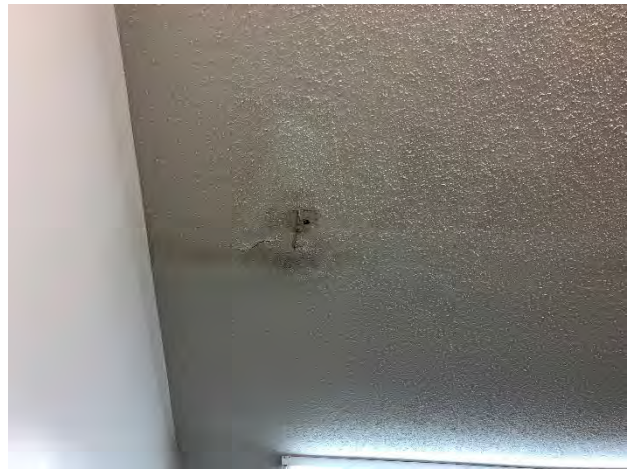
Figure 3-21 Water Damage to Richard Larson Ceiling

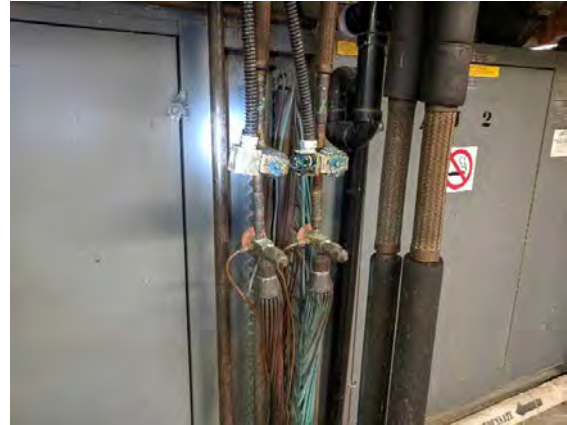
Figure 4-22 AHU-2 DX Coil Corrosion Visible

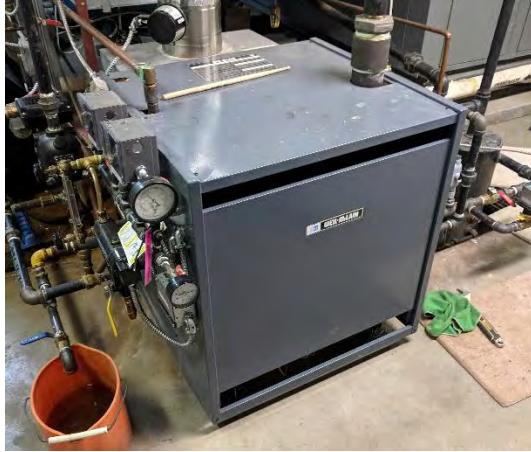
Figure 4-35 Steam Boiler in Mechanical Room

Steam boiler replaced in June of 2018 due to failure. Humidification piping is all original to building except a few elbows on the condensate lines which have corroded and failed causing leaks. Condensate tank also replaced in 2019 due to failure.

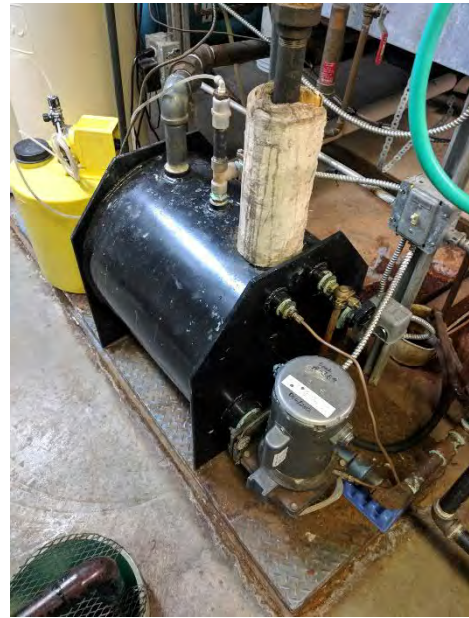
Figure 4-36 Condensate Collection Tank

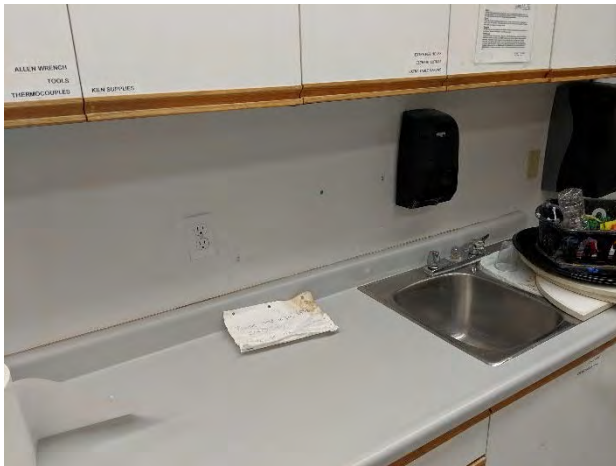
Receptacles located within 1.5 m of a sink must have GFI protection, currently none of the receptacles within 1.5 m have GFI protection. It is recommended to replace these receptacles with GFI type receptacles.

Figure 5-8 Receptacles Without GFI Protection

Elec.	Barr Colony Centre	Replace receptacles located near sinks with GFI type in Barr Colony Centre	Immediate	\$2,000
Elec.	Barr Colony Centre	Install Fire alarm devices as required per Code	Immediate	\$7,000

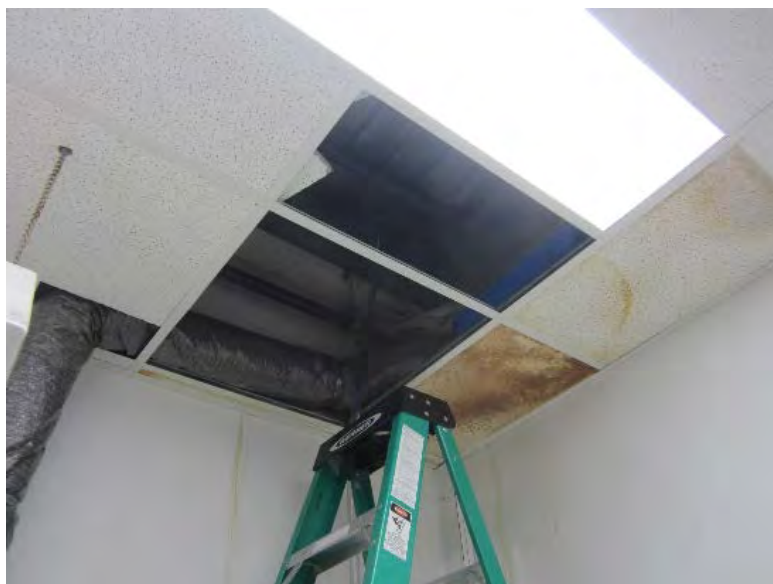
FIGURE 4 - Damage to Ceiling tile in Vault Area in BCHC due to Roof Leak

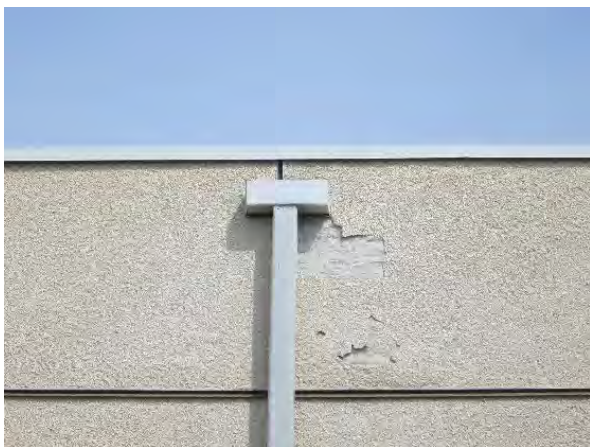
FIGURE 6 - Exterior Envelope Deterioration at Scupper

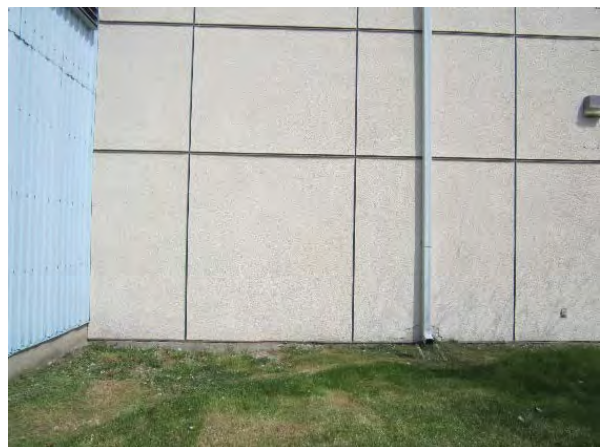
FIGURE 7 - Exterior Envelope Deterioration at Base
