This document entitled “Waterworks Master Plan and System Assessment 2016” has been prepared by ISL Engineering and Land Services Ltd. (ISL) for the use of the City of Lloydminster. The information and data provided herein represent ISL’s professional judgment at the time of preparation. ISL denies any liability whatsoever to any other parties who may obtain this report and use it, or any of its contents, without prior written consent from ISL.

**Reference: City of Lloydminster Waterworks Master Plan and System Assessment
Final Report Submission**

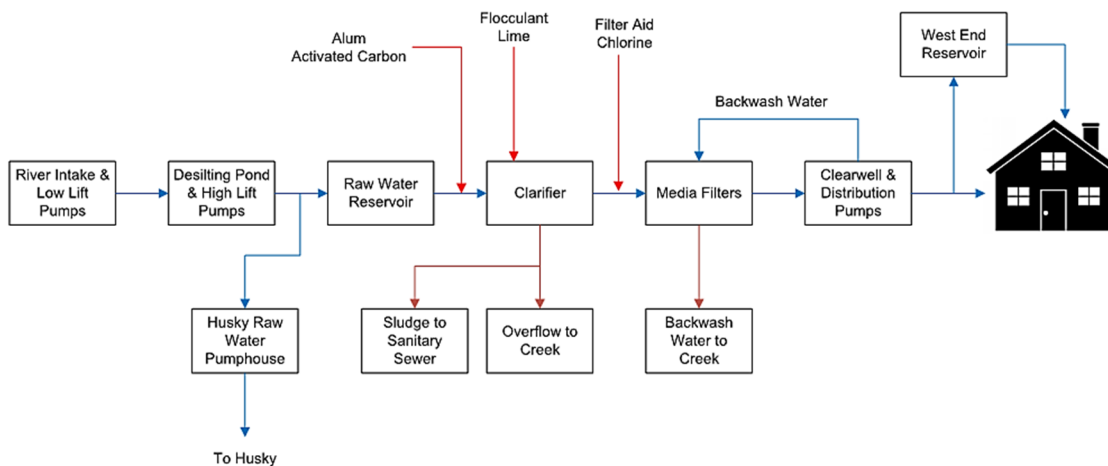
Figure 1.1: Process Flow Diagram

The following subsections will provide, in detail, a description of each of the sub-components within the three systems listed above. A Process Flow Diagram (PFD) entailing all the components described in this section is provided below (Figure 1.1).

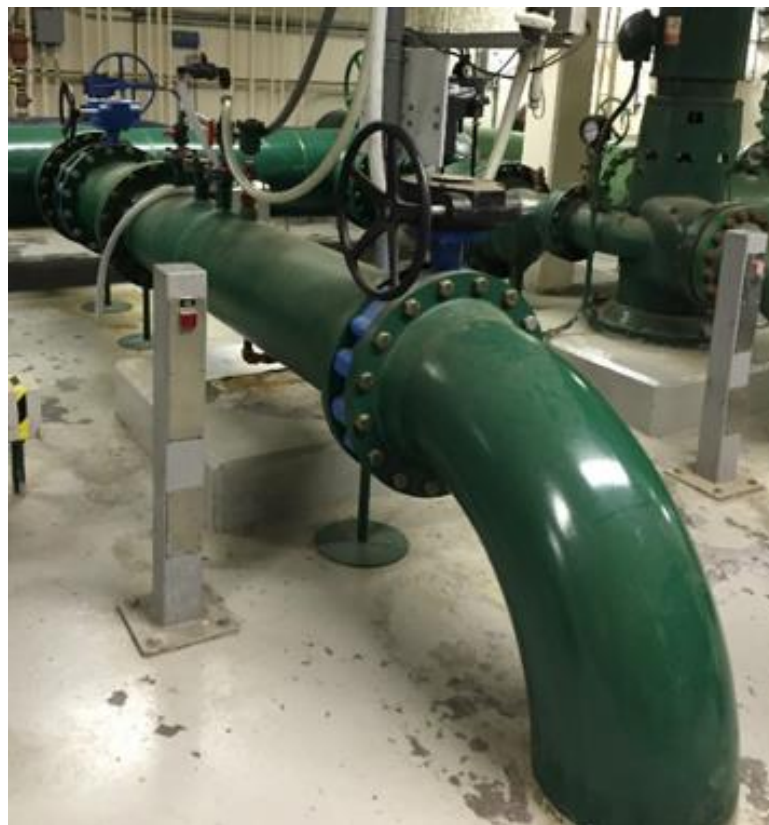
Raw Water Gravity Feed

Originally the raw water from the raw water reservoir was pumped into the WTP using combinations of three vertical inline centrifugal pumps, each with the capacity to provide 173.5 L/sec of flow (14,990 m³/day). However, due to the presence of significant head (elevation difference) between the raw water reservoir and the WTP, the City Operations' staff replaced one of the raw water pumps with a section of pipework. During normal operation, raw water now flows by gravity from the raw water reservoir into the WTP. Should the City experience high demands, the remaining two raw water pumps can be used to provide additional flow.

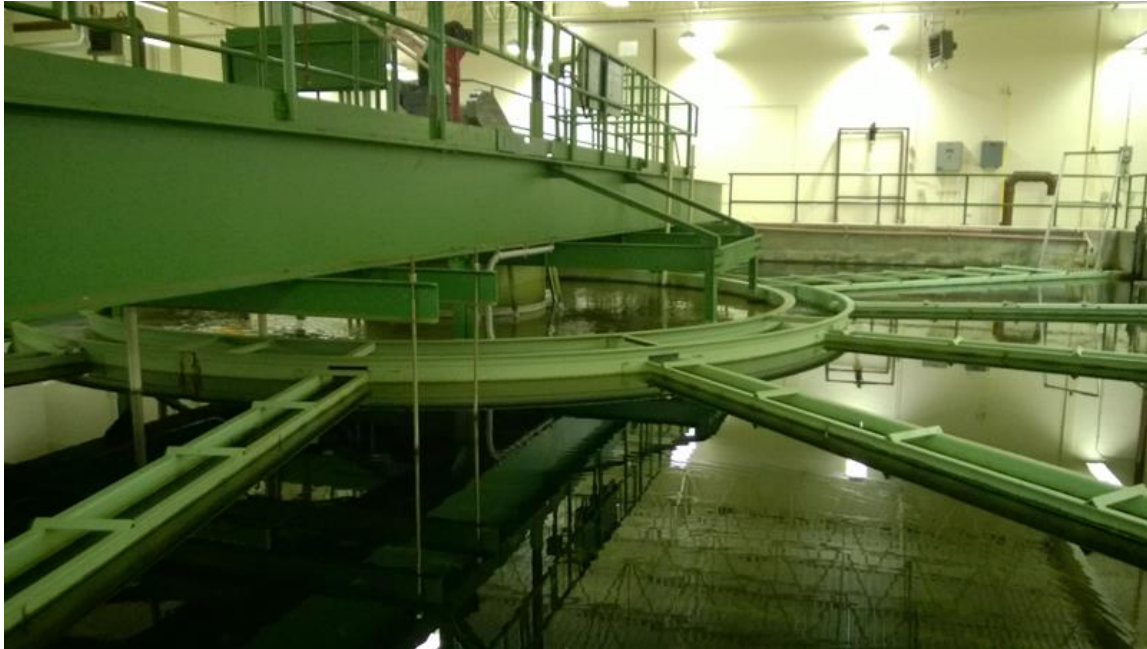
Solids Contact Clarifier

Following coagulation, the next process stage in the City's WTP consists of a single solids contact clarifier where the coagulated water undergoes flocculation and settlement. An anionic polymer is added to the water within the mixing zone of the clarifier, which encourages the micro floc to grow into macro-floc and settle using the recirculation of solids that are already within the clarifier. At the manufacturer's recommended maximum loading rate of 4.2 m/h and with an effective surface area of 210 m², the clarifier is currently rated to treat up to 21,168 m³/day, based upon a 24 hours of continuous operation.

In the event that the single clarifier has to be taken off line for maintenance, the clarifier can be bypassed and direct filtration used to treat the water. Once isolated, the two sludge pumps that are used to waste excess sludge from the clarifier to the sanitary sewer are used to completely drain the clarifier.

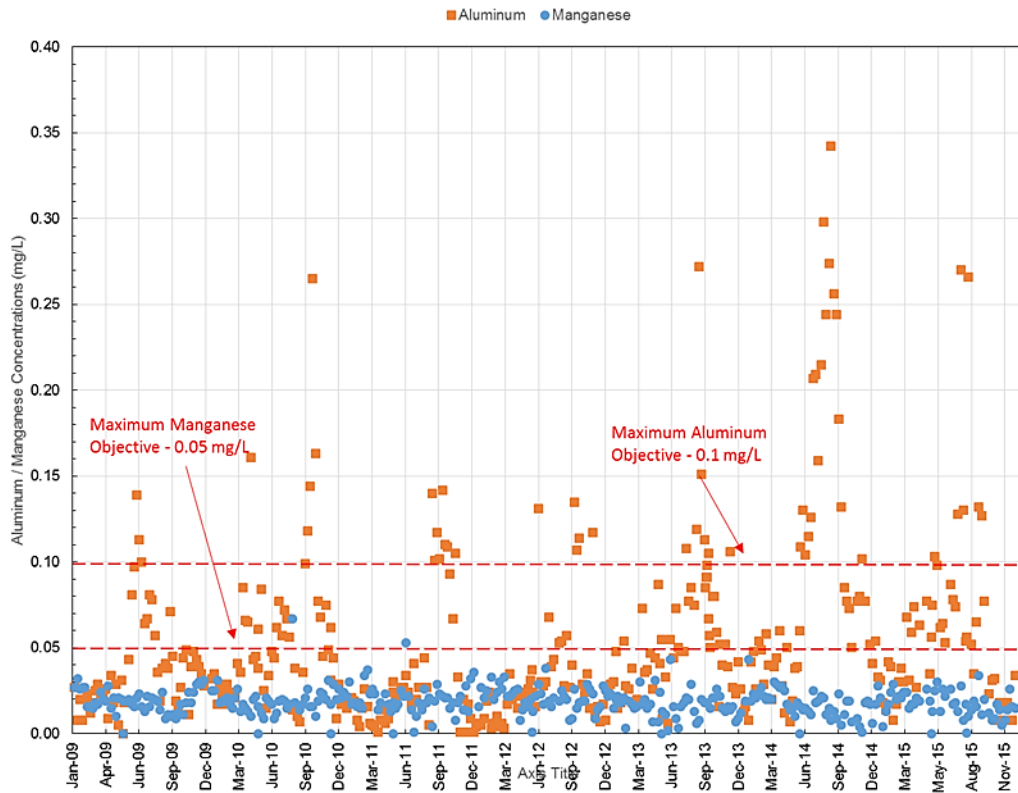
Figure 4.8: Treated Water Aluminum and Manganese Concentrations

Figures 4.9 below illustrates the concentrations of Aluminum and Manganese within the treated water for the reporting period. It is important to note that while these concentrations exceed the objectives, these are not enforceable standards and that the 2009 to 2015 average values for each of these parameters is significantly below their respective objectives/guidelines. Therefore, it is anticipated that these parameters will not pose a threat to the quality of drinking water supplied to the consumers.

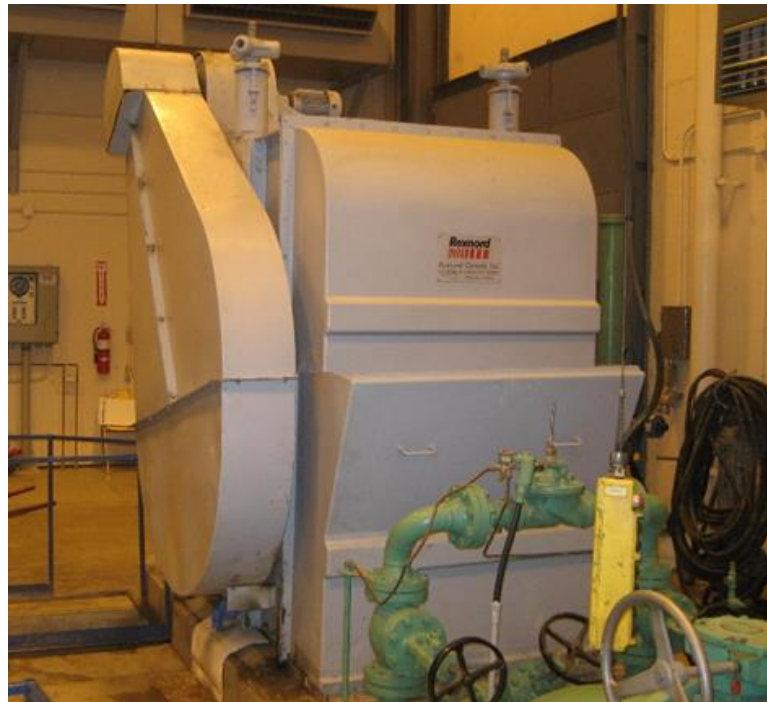
In terms of future hydraulic capacity, the values presented in Table 6.1 also apply to the screen, which is capable of meeting the project demands beyond the next 30 years. Based upon the observations made by ISL, the screen is not in any serious state of disrepair, apart from spillage resulting from the oil bath, which is being contained by adsorption pads. In 2013 the City's staff undertook an inspection of the screen below the main floor, from which no serious concerns or issues were raised.

On the basis that the screen is maintained and parts /components are fabricated and replaced when issues are identified, the raw water intake screen should continue to operate beyond next 10 years.

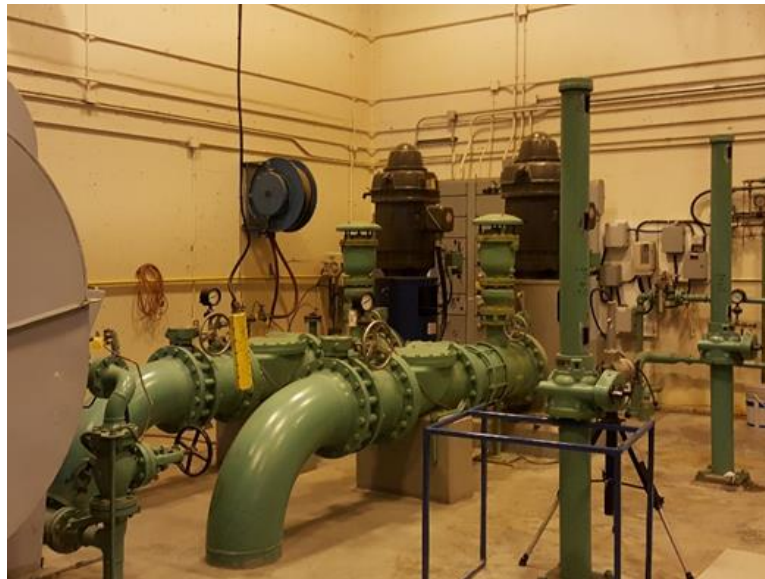
Once through the intake screen, the river water is lifted, using two low lift pumps, into a U-shaped desilting pond where sediment and other material is settled out of the water. Both low lift pumps are installed with variable frequency drives and have a pumping capacity of 347 L/sec (30,000 m³/day) at a discharge pressure of 9 m.

Historical turbidity results, shown in Table 4.1, show that the desilting pond is efficient in removing suspended solids from the river water, thus reducing the solids loading on the water treatment plant (WTP). In reviewing this data, the variations in the pond outlet turbidity correlated with the variations in the inlet turbidity rather than the flowrate through the pond.

Table 6.2 shows the projected average and maximum raw water flowrates that will pass through the system in the next 30 years. As a single pump provides a flowrate of 30,000 m³/day, it will be necessary to run the second low lift pump on a more regular basis as raw water demand increases (i.e. within the next 5 to 10 years). As the operation of two low lift pumps is a condition that the operational staff wish to avoid at this time, addressing the sand and sediment infiltration issue becomes a higher priority for both operational and maintenance reasons.

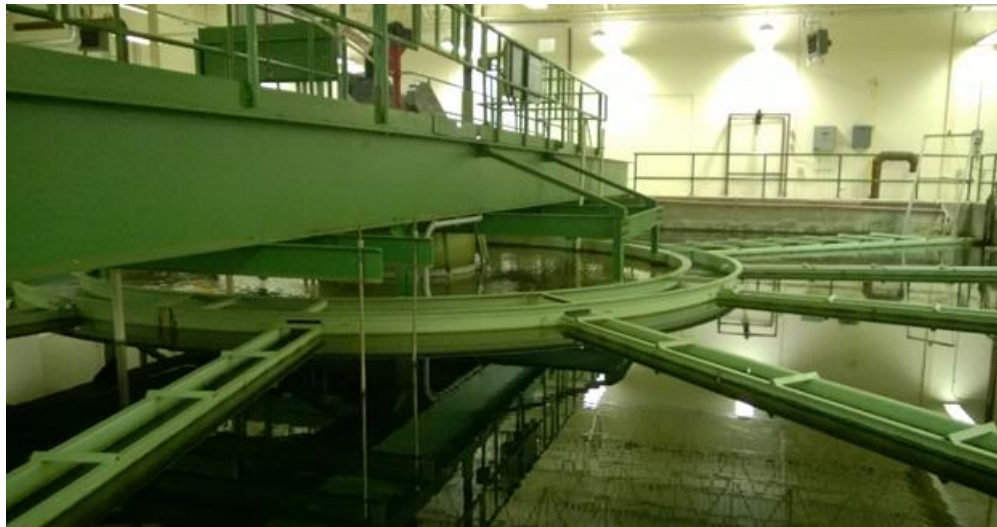
Figure 6.1: Solids Contact Clarifier Surface Loading Rate and Outlet Turbidity

Using the data collected between 2009 and 2015, instantaneous flowrates based on a 16 hour and 22 hour daily run times were calculated and plotted against the clarifier outlet and treated water turbidity. As shown in Figure 6.1, the clarifier outlet turbidity varies throughout the years, and consistently stays below 1.0 NTU within only a few exceedances above this self-imposed operational guideline.

As noted above, Turbidity is not really true representation of what is occurring within clarifier and how it impacts the process downstream. It is sludge carry over and the sludge blanket integrity that are the important controlling factors with regards to this type of clarification technique. At certain times of the year when conditions are right the clarifier can treat more water than it is rated for (red line within Figure 6.1), however a change in a single water quality parameter (i.e. higher organics) can unbalance the alum dose and the now incorrect mixing speed or a deep sludge blanket for this change in raw water quality can cause the sludge blanket to break up and carry over onto the filters, blinding them. This is further illustrated within Figures 6.2 to 6.4, which show variations in measured parameters across the clarifier and how in some cases they affect one another, or not.

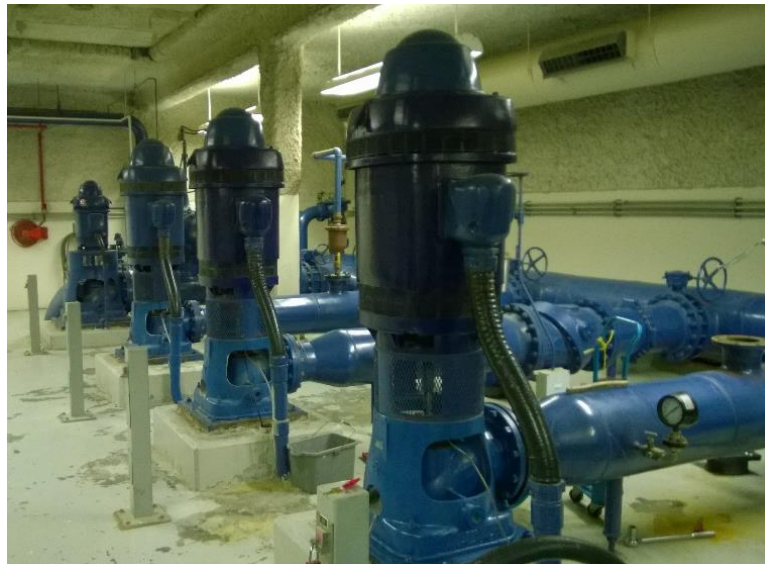
Water from within the clearwell is pumped into the distribution system using a combination of the three pumps originally installed in 1984 and overhaul in 2003. The installation is comprised of two fixed speed pumps (PWP-101 and PWP-102) each with a capacity of 16,532 m³/d at a discharge pressure of 61 m (598 kPa) and one variable speed pump (PWP-103) which has a capacity of 13,488 m³/d at a discharge pressure of 59 m (578 kPa).

The water from the WTP is currently discharged directly into the distribution system, with any unused demand entering the West End Reservoir (Reservoir). Under a “normal day” the water demands of the system are currently met by water supplied from both the WTP and the West End Reservoir, as there is another set of pumps at the Reservoir that also feed the distribution system. As demand drops away in the evening, the surplus water from the WTP is used to refill the Reservoir. Once full, the water from the WTP continues to meet the distribution system demands until it is shut down for the evening. Overnight demands are then solely met by the West End Reservoir until the WTP restarts the following morning. Due to the current pipework configuration, the West End Reservoir cannot be filled and used to maintain pressure in the distribution system at the same time.

As noted within the previous WSAs, the supply of water to the distribution system from the WTP, which also feeds the West End Reservoir, is restricted in some way. Work has continued since the last WSA to identify the restriction within the distribution system, however conflicting results and the inability to repeat previous test results have prevented the City from solving this issue. With regards to the rest of the operation of the WTP distribution pumps no other issues were raised by the City's staff.

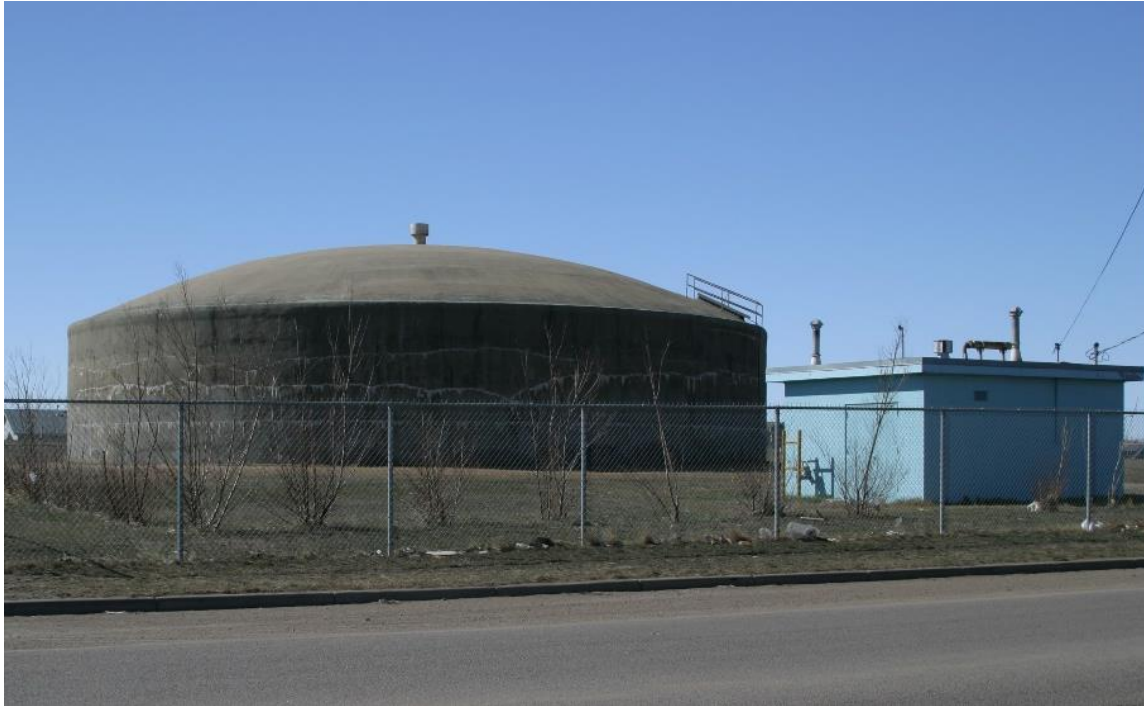
In 2010, a structural assessment of the above ground reservoir was undertaken to assess the adequacy of the structure and identify any significant problems. The conclusion of the assessment was that the reservoir was in a poor to fair condition with evidence of micro-cracks and exposed rebar. The remaining service life of the reservoir was estimated to be order to 10 years in its assessed condition, and requirements for further analysis and assessment were noted prior to providing recommendations for remedial work to prolong the life of the reservoir. The 2006 below ground reservoir can still be classified as a recent construction and as such has an expected service life in excess of 30 years.

As part of previous work by ISL, the subsequent development of the West End Reservoir was planned in two further stages:

- Stage 2 – The addition of 9,850 m³ to the existing underground reservoir providing a total storage capacity of 34,596 m³, and
- Stage 3 – Demolition of the above ground reservoir and construction of a further 11,000 m³ of storage, providing a total capacity of 41,051 m³.

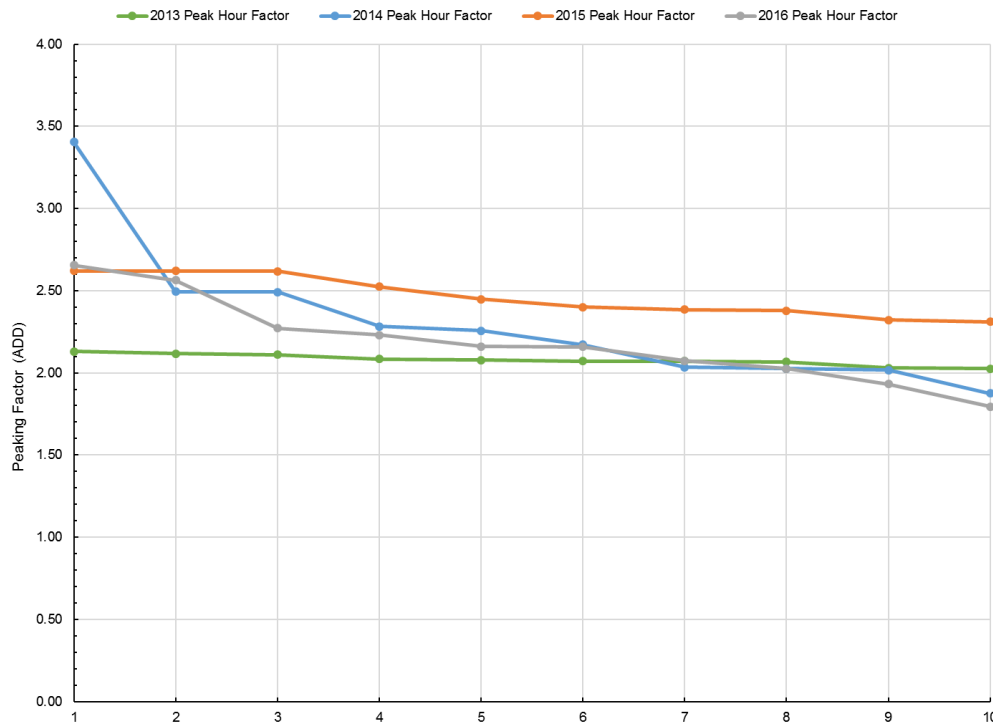
Figure 6.7: Historical Peaking Factor for Hourly Demands

Using the above information, each year from 2013 to 2015 has been displayed alongside one another in Figure 6.7 below. In reviewing this data with the City, it has been confirmed that the peaking factor of 3.41 that occurred in 2014 was the result of the reservoir fill valve sticking open which resulted in water recirculating back into the Reservoir. As such this high value will be discounted from the analysis. In considering the remaining information, the highest hourly peaking factor for each year occurs in the 2.2 to 2.67 range, which depending on the year is either repeated or the succeeding highest values slowly reduces. This indicates that the peak hourly flows experienced within the system are consistent and thus can be used for establishing an hourly peaking factor. On the basis of this information and to provide suitable safety factor, the City agreed to ISL recommendation of applying a peaking factor of 3.0 times the ADD to the future predictions for hourly demands. This aligns with the peaking factor for hourly demands applied to the Distribution Master Plan, and the suggestion of 2 to 5 times the ADD provided by the Alberta Environment Guidelines (There is no indication in the Saskatchewan Guidelines).
