This document entitled “Waterworks Master Plan and System Assessment 2016” has been prepared by ISL Engineering and Land Services Ltd. (ISL) for the use of the City of Lloydminster. The information and data provided herein represent ISL’s professional judgment at the time of preparation. ISL denies any liability whatsoever to any other parties who may obtain this report and use it, or any of its contents, without prior written consent from ISL.

**Reference: City of Lloydminster Waterworks Master Plan and System Assessment
Final Report Submission**

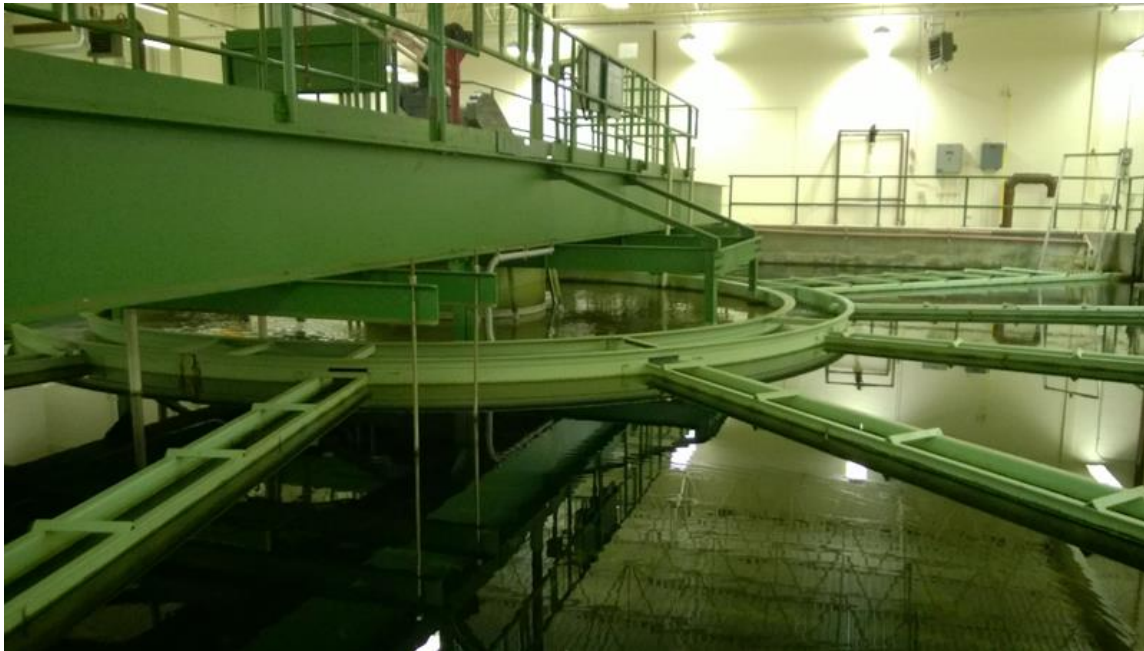
Solids Contact Clarifier

Following coagulation, the next process stage in the City's WTP consists of a single solids contact clarifier where the coagulated water undergoes flocculation and settlement. An anionic polymer is added to the water within the mixing zone of the clarifier, which encourages the micro floc to grow into macro-floc and settle using the recirculation of solids that are already within the clarifier. At the manufacturer's recommended maximum loading rate of 4.2 m/h and with an effective surface area of 210 m², the clarifier is currently rated to treat up to 21,168 m³/day, based upon a 24 hours of continuous operation.

In the event that the single clarifier has to be taken off line for maintenance, the clarifier can be bypassed and direct filtration used to treat the water. Once isolated, the two sludge pumps that are used to waste excess sludge from the clarifier to the sanitary sewer are used to completely drain the clarifier.

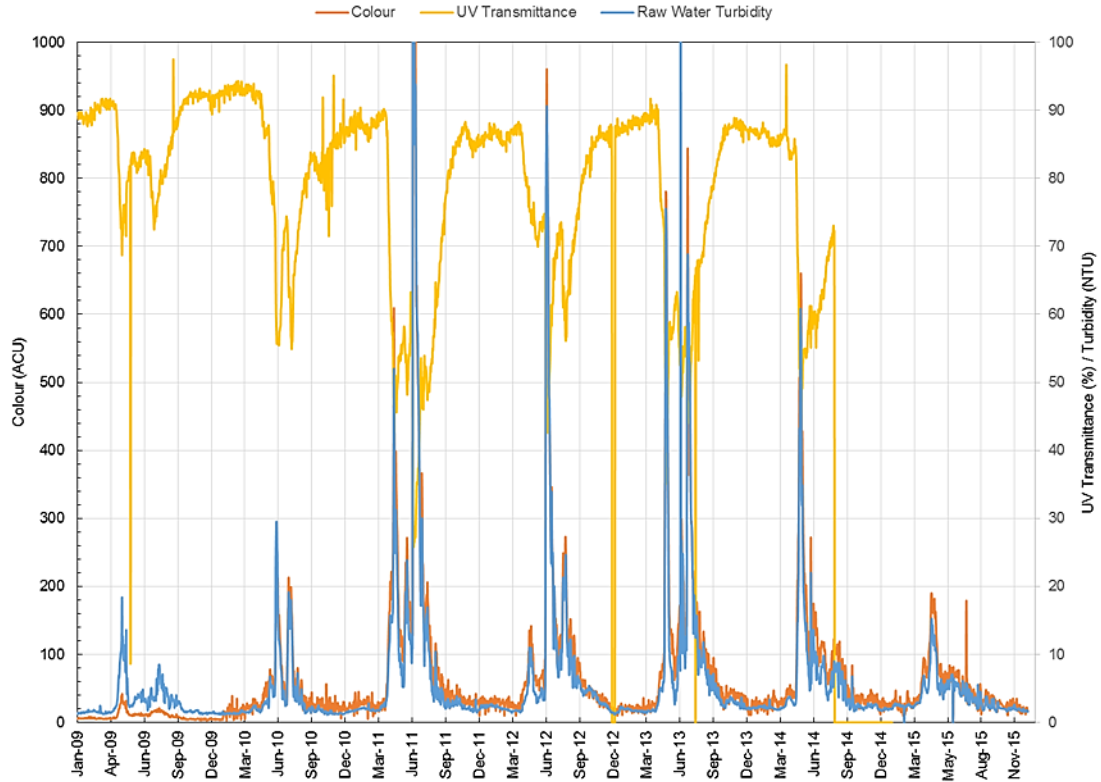
Figure 4.4: Raw Water UV Transmittance, Turbidity and Colour, 2009 to 2015

In focusing on the raw water which enters the WTP, Figure 4.5 below illustrates the reservoir outlet results for UV transmittance, turbidity and colour. As expected, the drop in transmittance corresponds with peaks in colour and turbidity. This indicates that actual colour rather than true colour is being measured and that changes in UV transmittance is associated with the normal natural cycle.

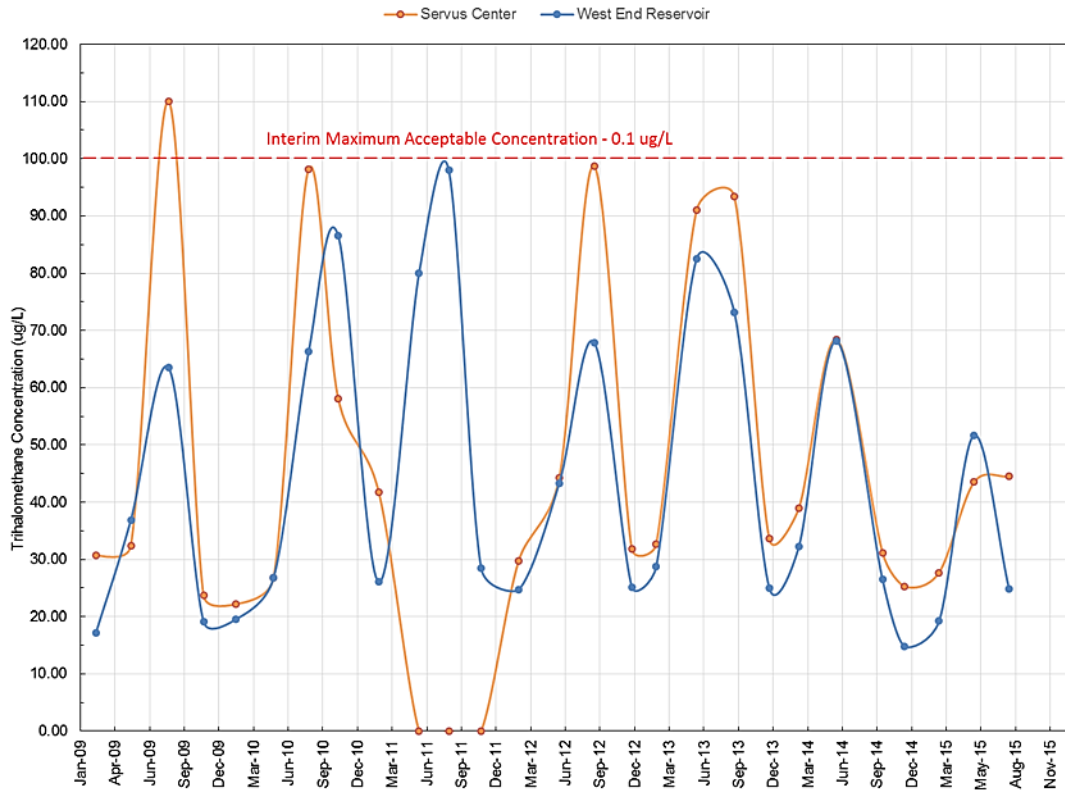
Figure 4.14: Trihalomethanes Concentrations within the Distribution System, 2009 to 2015

affected by the age of the water within the system, the temperature of the water and the free chlorine residual that is present.

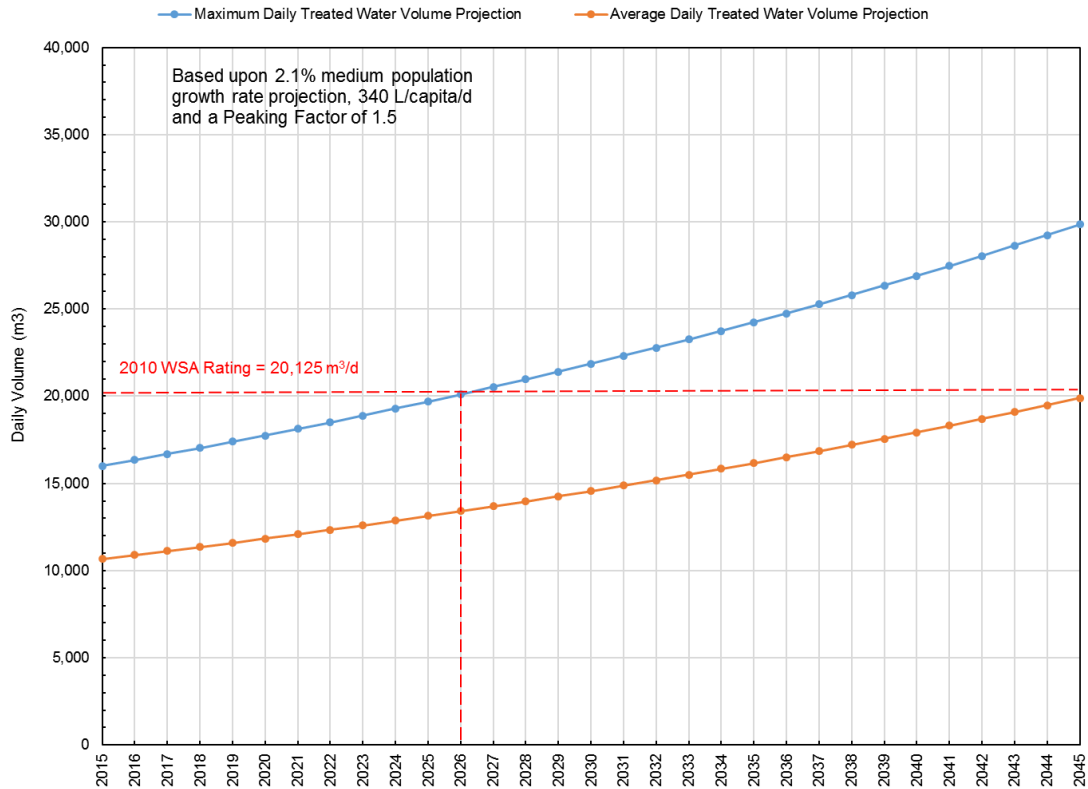
Figure 5.4: Projected Future Maximum and Average Daily Treated Water Volumes for WTP

2015	2018	2020	2025	2035	2045
Year	0	3	5	10	20	30
Projected Population	31,377	33,396	34,813	38,625	47,547	58,531
Average Daily Treated Water Volume (m3)	10,668	11,354	11,836	13,133	16,166	19,900
Maximum Daily Treated Water Volume (m3) (5 Day Rolling Average)	16,002	17,032	17,755	19,699	24,249	29,851
