LCSC Visitor Experience Report

Lloydminster Cultural and Science Centre Condition Assessment

Associated Engineering Alberta Ltd. (AE) carried out a visual review and condition assessment of the Lloydminster Cultural and Science Centre on May 8, 2019.

Lloydminster Cultural and Science Centre Condition Assessment (Architecture)

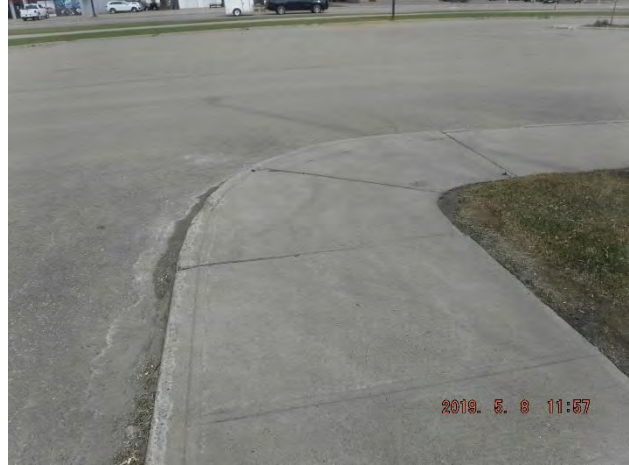
Figure 2-6 Parking Lot: Curbs with Edge Breaks

The parking lot is bound by straight face concrete curbs. Based on a visual assessment, the curbs are generally in a good condition, however, some curbs have cracks, and some curbs have chips and some have edge breaks as shown on Figure 2-5 and Figure 2-6.

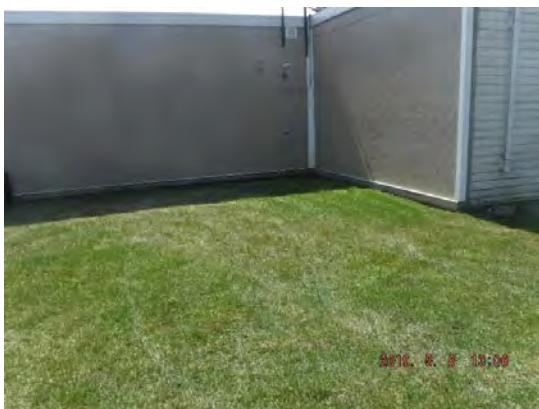
Figure 2-10 Back Graded: East Section (Fuchs gallery)

Parts of the east section of the site slope towards Fuchs Wildlife Centre and Interactive Oil Displays as shown on Figure 2-1, Figure 2-10, and Figure 2-11.

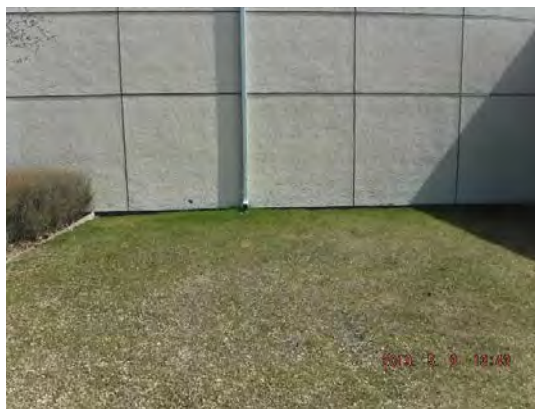
Figure 2-11 Insufficient Grading: West Section (Imhoff gallery)

The west side of the Main Building adjacent to the Imhoff Gallery is graded along the building. The grading is not uniform and landscaping features may be inhibiting flow. This may encourage ponding of water, increasing the likelihood of ingress of water into the building. The LCSC officials indicated that no ingress of water through the walls has occurred into the building.

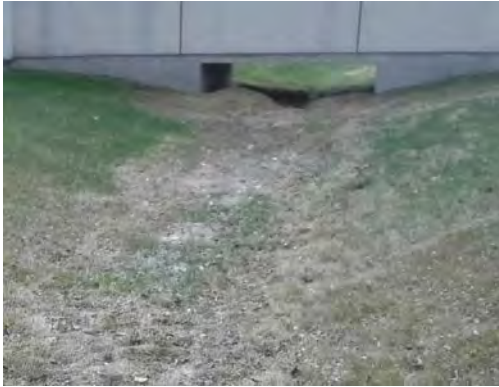
Figure 2-12 Swale

A swale drain is located between the Fuchs Building and the Interpretive Building as shown on Figure 2-1. This swale collects surface runoff from the rear of the main building and discharges it into the stormwater system located across the parking lot. Based on a visual inspection, the drain does not comply with the minimum 1.5% slope requirements for grassed swales as per the City of Lloydminster Municipal Development Standards of 2014. Parts of the swale have been eroded while some parts are partially blocked as shown on Figure 2-12 and Figure 2-13.

The swale may also be contributing to moisture problems observed in the parking lot as it discharges onto the parking lot. Some of the runoff discharged from the swale maybe entering the subsurface portion of the pavement structure of the parking lot.

A 200 mm Corrugated Steel Pipe which discharges into the swale is partially blocked.

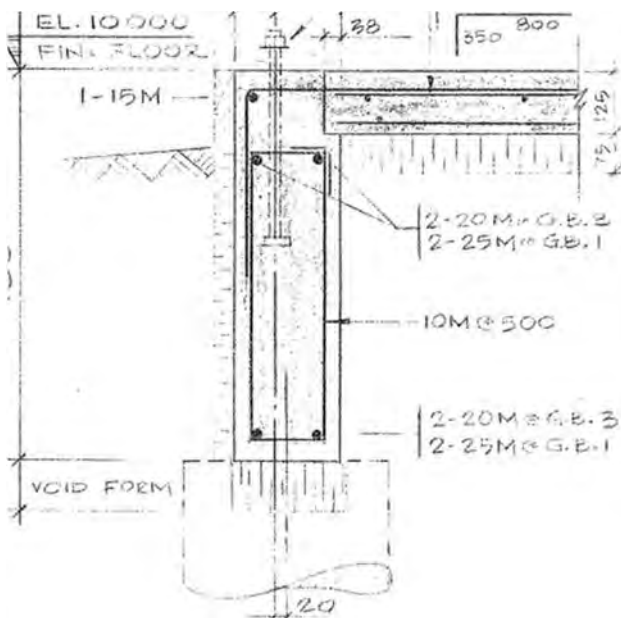
Figure 3-1 Example of Concrete Grade Beam on Pile

The foundations were not visible for inspection due to their location in soils. With no visible signs of concern, it is assumed that these items are in satisfactory condition.

It appears that a groundwater collection system is not provided around the buildings perimeter. A structure without a collection system has a greater risk of soil saturation and frost heave. Our understanding is that there has been no history of frost heaving of the structure and therefore, has been performing adequately.

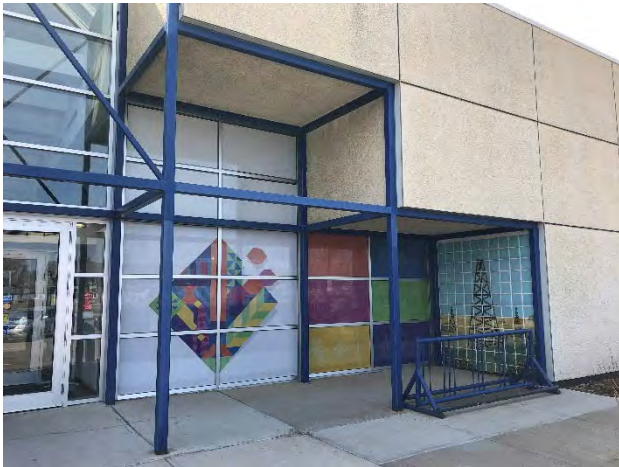
Figure 3-14 Viewing Main Entrance Framing

Most of the structural steel framing is hidden within walls. Visible columns were assessed and appeared to be in good condition with one exception; exterior columns of the main entrance have minor surface corrosion. These surfaces shall be prepared and recoated for protection.

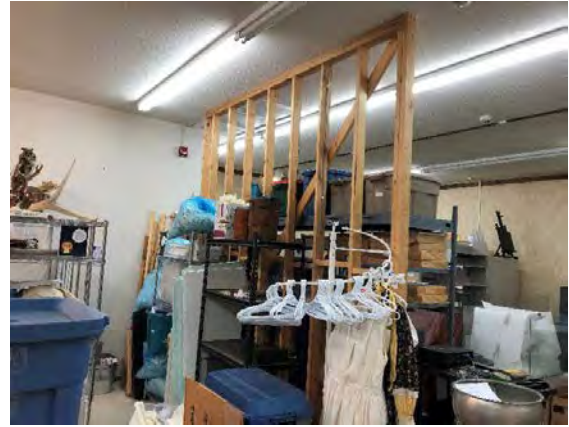
Figure 3-19 Temporary Timber Framed Supports

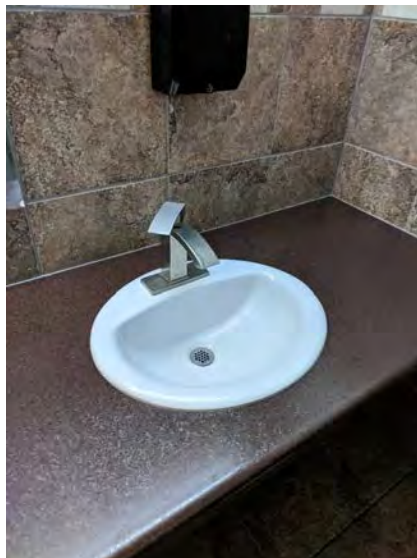
Figure 4-1 Typical LAV Found in Men and Women's Washroom by Main Entrance

This type of lavatory and sink are found in the Men and Women’s Washroom near the main entrance and in the Barrier-Free Washroom located in the corridor between the old Larson Building and Pottery Area.

- Lavatory sinks appear to be in good condition (no visible cracks).
- UBERHAUS faucets appear to be newer and functioning as intended.
- Replace only when damaged.
- 2015 Building Code requires lavatories be supplied with faucets capable of automatically shutting off.
- Low Priority.

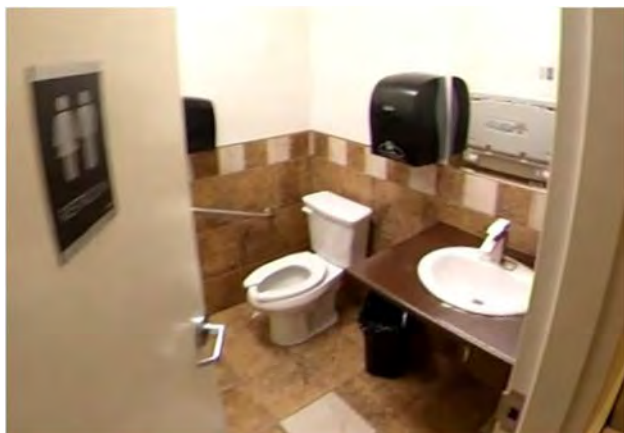
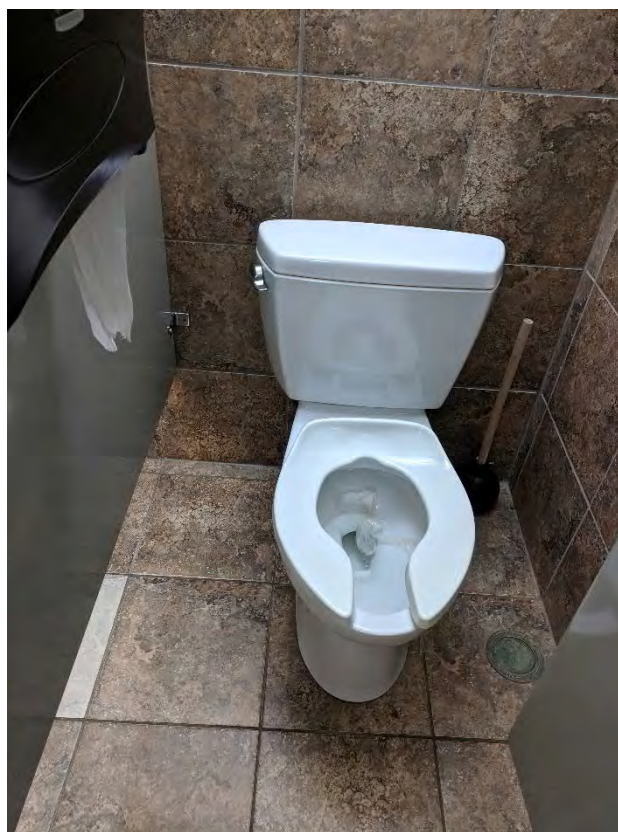
Figure 4-2 Barrier-Free Washroom Near Pottery Area

Figure 4-3 Typical Toilet Found in Men and Women’s Washroom Near Main Entrance

There are two types of water closets found in the Men and Women’s Washroom near the main entrance and in the Barrier-Free Washroom located in the corridor between the old Larson Building and Pottery Area.

- TOTO water closets in the Men’s and Women’s Washrooms are 6 LPF.
- Penguin water closet in the Barrier-Free Washroom is 4.2 LPF.
- All water closets tested to flush and appear to be in fair working order.
- Both types of water closets appear to be newer.
- Upgrading to 1.2 LPF toilets is recommended for the Men’s and Women’s Washrooms to reduce water consumption.

- Replace only when damaged.
- Low Priority.

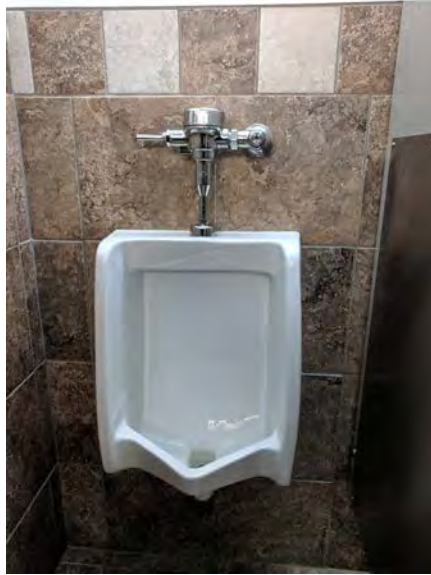
Figure 4-4 Urinal in Men's Washroom Near Main Entrance

One urinal found in the Men's washroom near the main entrance.

- Delta low-flow (0.5-1.9LPF adjustable) manual flush valve with vacuum breaker.
- Urinal bowl appears to be an American Standard Washbrook.
- Urinal flush valve was tested and appears to be working.
- Both flush valve and urinal bowl appear to be in fair working condition.
- Replace only when damaged.
- Low Priority.

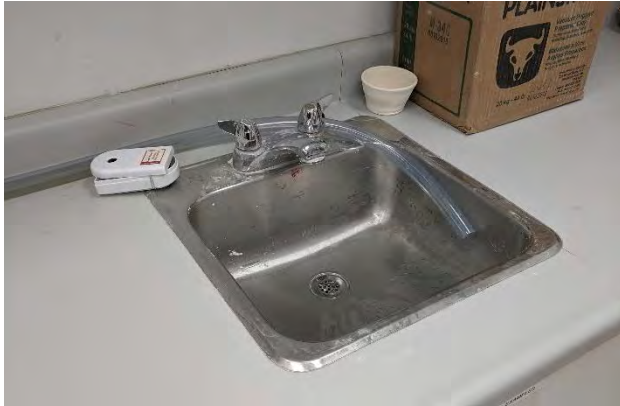
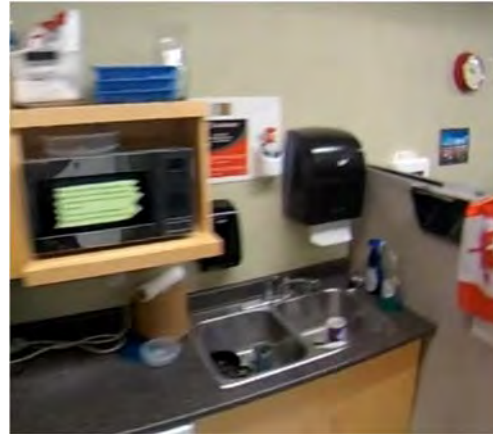
Figure 4-5 Sink Found in Kiln Room

Figure 4-6 Double Sink Found in Staff Area

Sinks were found in the Kiln Room, Staff Area, and Pottery Area.

- Cold water tap in the Kiln Room was found to be non-operational.
 - Cold tap would not turn.
 - Replacement of faucet is recommended.
 - Medium Priority.
- Other sinks in the building were tested and found to be operational.

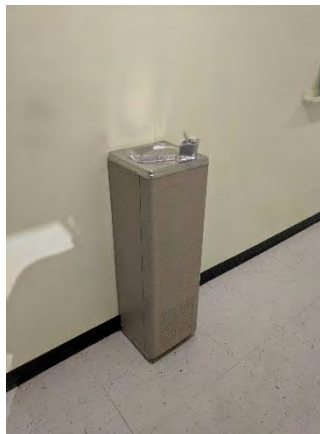
Figure 4-7 Drinking Fountain Near Barrier-Free Washroom by Pottery Area

Drinking fountain appears to be in fair working order.

- Drinking water has sour metallic taste after 1 minute of water running at time of visit
- Water cooled water chiller life span expected to be 15 years.
- Remaining service life of unit is 6 years.
- Medium Priority for replacement.

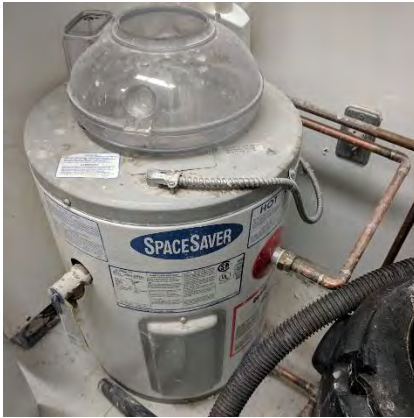
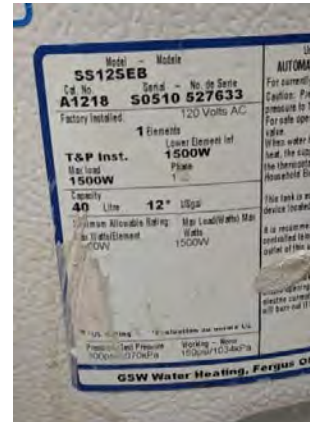
Figure 4-8 Electric Water Heater in the Kiln Room

Figure 4-9 Electric Water Heater Nameplate Data

The electric water heater in the Kiln Room is assumed to be the same age as the other equipment within the room, approximately 9 years old, according to the Operations Team.

- Space saver water heater appears to be in fair working order and provides hot water for the Kiln Room.
- ASHRAE HVAC Applications 2015 service life estimates.
 - Electric hot water heater at 15 years.
- Estimated remaining life at 6 years.
- Medium priority for replacement.

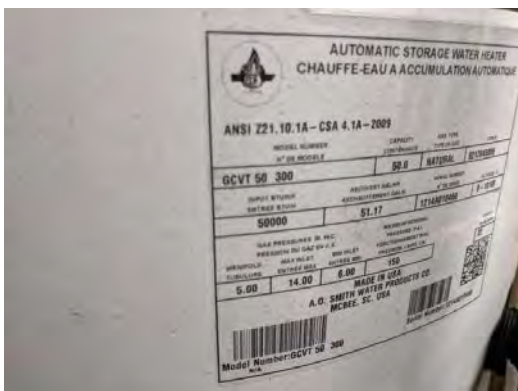
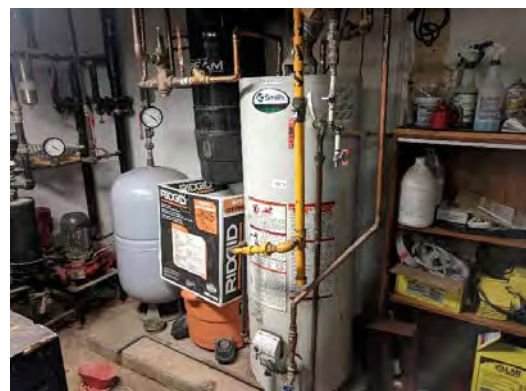
Figure 4-10 Gas Fired Domestic Water Heater Data

Figure 4-11 Gas Fired Domestic Water Heater System

The gas fired water heater in the Mechanical Room was replaced in 2012.

- AO Smith water heater appears to be in fair-working order and provides hot water for the Barr Colony Cultural Centre.
- General domestic water piping in Mechanical Room appear to be corroded.
- Service life estimate for gas fired water heaters to be 15 years.
- Estimated remaining life at 8 years.
- Medium Priority for replacement.

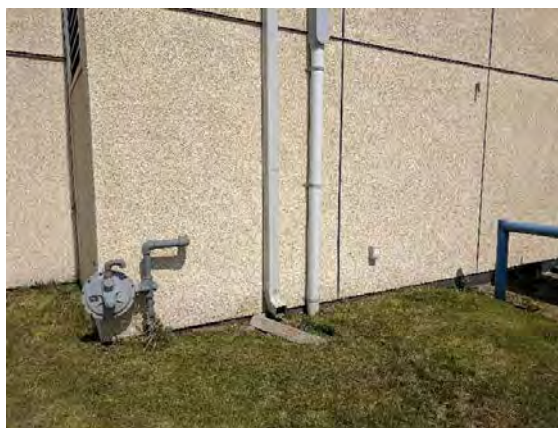
Figure 4-12 Rainwater Leader

- Operators did not note any concerns with the sanitary system.
- All buildings use scuppers and exterior rain water leaders to drain rainwater.

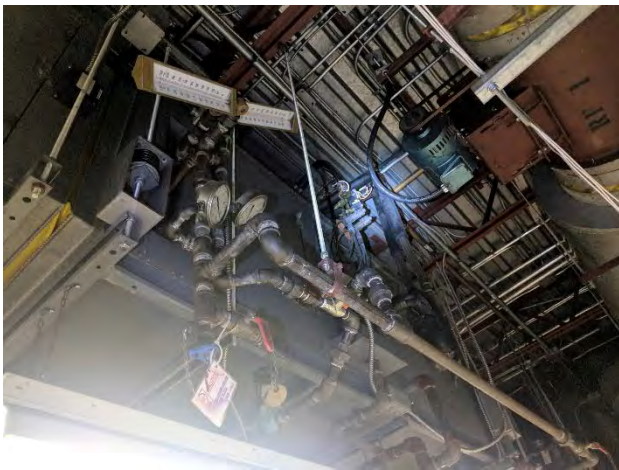
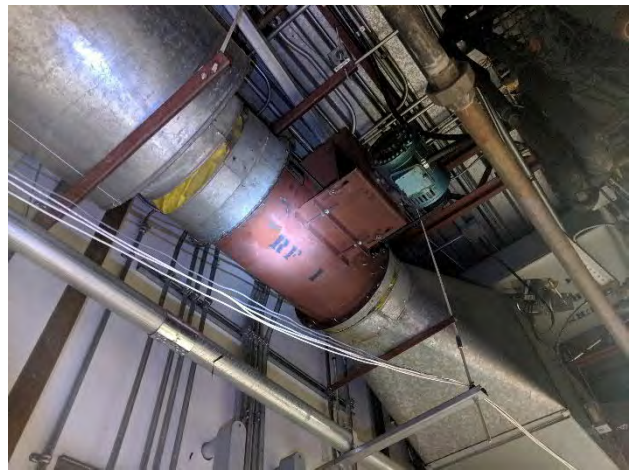
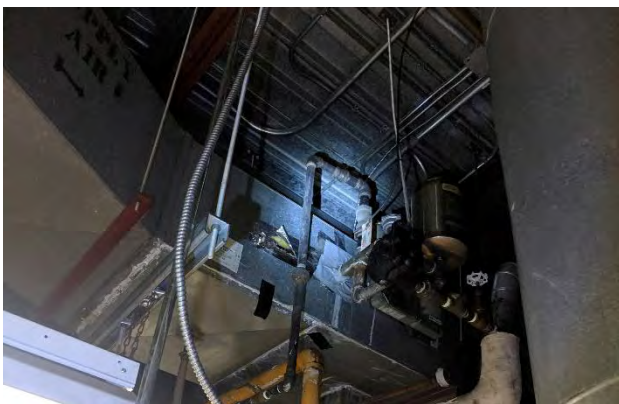
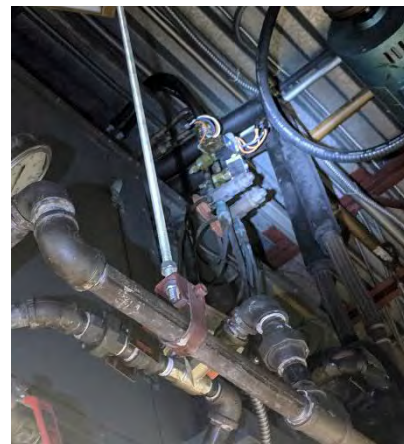
Figure 4-15 AHU-1 Suspended From Roof

Figure 4-16 RF-1 Suspended From Roof

Figure 4-17 AHU-1 Steam Section with Ductwork Tear Visible

Figure 4-18 AHU-1 DX Coil Corrosion Visible

Original to building Engineered Air – Air handling system with separate return fan section, separate filter section, separate mixing section and return silencer. The air handling equipment is estimated to be 31 years old.

- Engineer Air - Air handler appears to be operating.
- ASHRAE HVAC Applications 2015 service life estimates.
 - Centrifugal fans at 25 years.
 - Axial Fans at 20 years.
 - Steam, DX and Water coils at 20 years.
- Supply and return fan serving AHU-1 has exceeded useful service life.
- Both supply and return fans appear to be operating in fair working order.
- Ductwork is original to building is likely to be leaky.
- Heating and cooling coils serving AHU-1 has exceeded useful service life
 - The heating and cooling coils appear to be in fair working order.
 - Cooling capacity of air handler was noted to be insufficient by operator.
 - Humidification capacity of air handler was noted to be insufficient by operator.
- Immediate replacement of whole system is recommended.

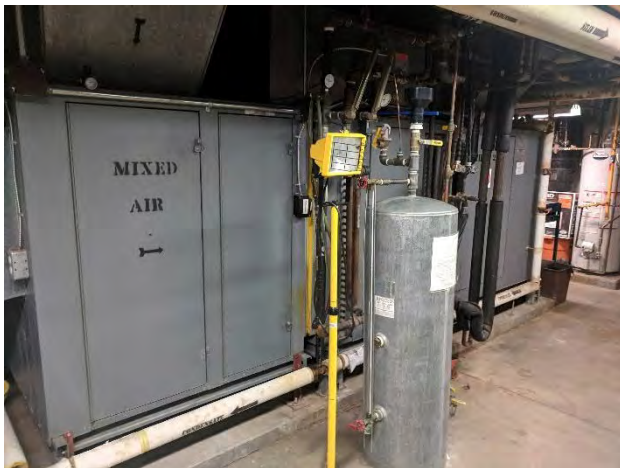
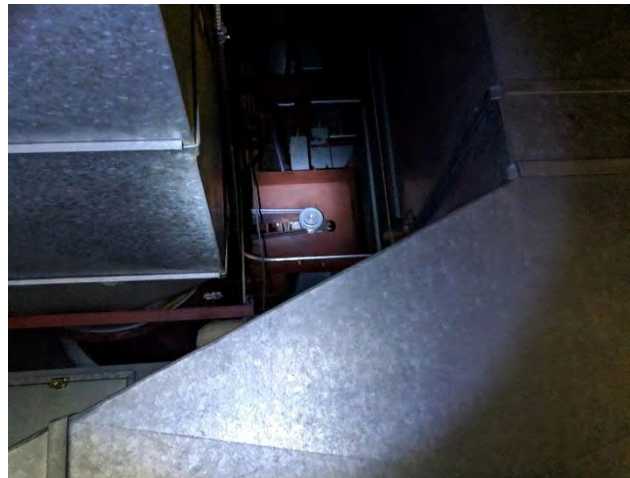
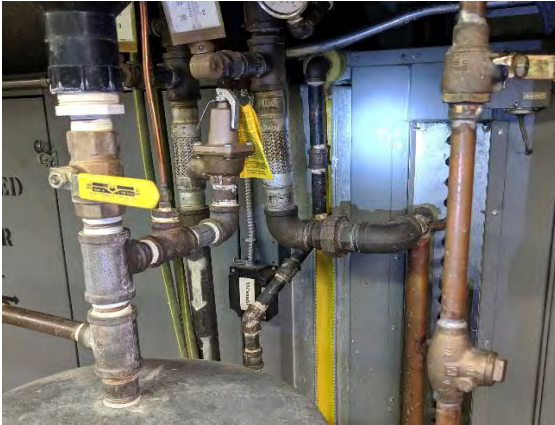
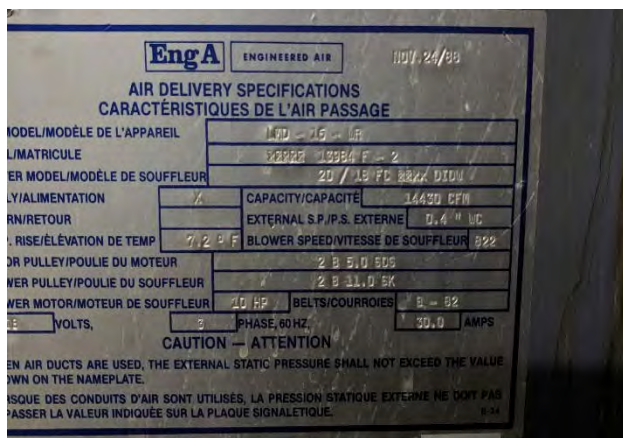
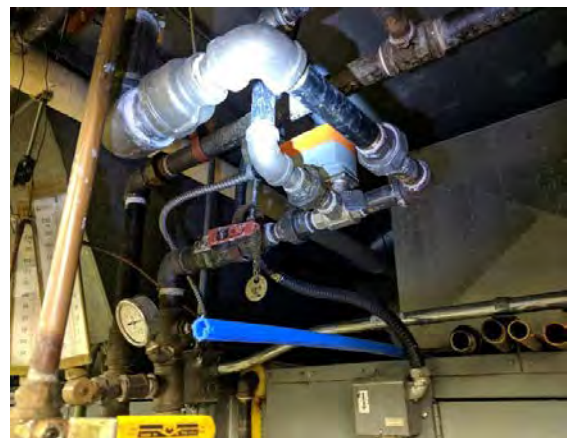
Figure 4-19 AHU-2 on Pad

Figure 4-20 RF-2 Suspended From Roof, Not Easily Accessible

Figure 4-21 AHU-2 Heating Coil

Figure 4-23 AHU-2 Nameplate

Figure 4-24 AHU-2 Heating 3-Way Control Valve

Original to building Engineered Air – Air handling system with separate return fan section, separate filter section, separate mixing section and return silencer. The air handling equipment is estimated to be 31 years old.

- Engineered Air - Air handler appears to be operating.
- Zone reheat coils were not accessed/accessible and assumed to be original.
- ASHRAE HVAC Applications 2015 service life estimates.
 - Centrifugal fans at 25 years.
 - Axial Fans at 20 years.
 - Steam, DX and Water coils at 20 years.
- Supply and return fan serving AHU-1 has exceeded useful service life.
 - Both supply and return fans appear to be operating in fir working order.
- Zone reheat coils are original to building.
 - Zone reheat coil controls is likely original to building.
 - Miscellaneous HVAC section covers controls replacement.

- Heating and cooling coils serving AHU-1 has exceeded useful service life.
 - The heating and cooling coils appear to be in fair working order.
 - Cooling capacity of air handler was noted to be insufficient by operator.
 - Humidification capacity of air handler was noted to be insufficient by operator.
- Immediate replacement of whole system is recommended.

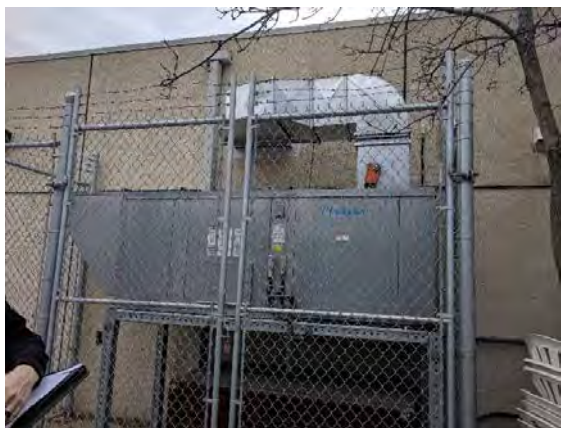
Figure 4-25 MUA-1 Outside Kiln Room

- Greenheck - MUA-1 appears to be in good working order.
- MUA-1 was operating at time of visit.
- ASHRAE HVAC Applications 2015 service life estimates.
 - Centrifugal fan at 25 years.
 - Burners at 21 years.
- The remaining service life is 18 years.
- Operator noted that MUA-1 has to run all the time since it also provides heating to Pottery Area, and not just the Kiln Room.
- Low Priority for replacement.

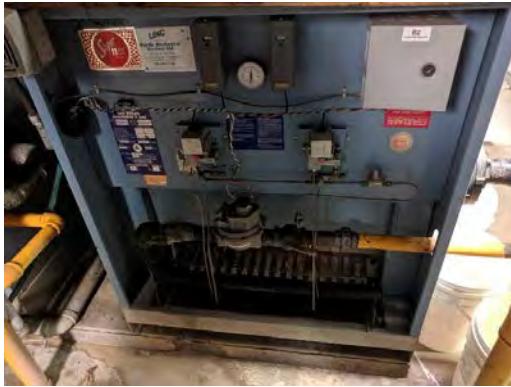
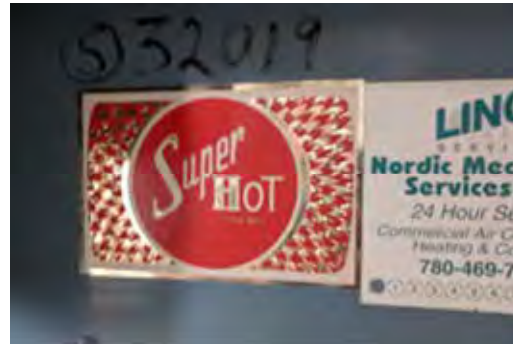
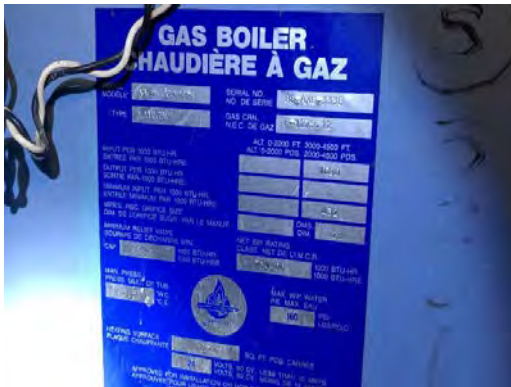
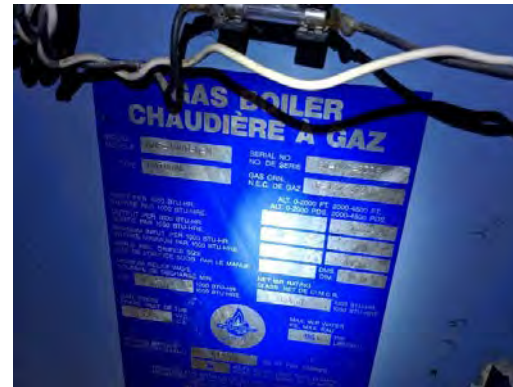
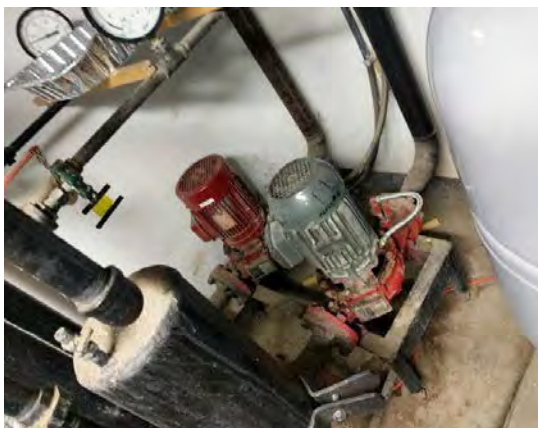
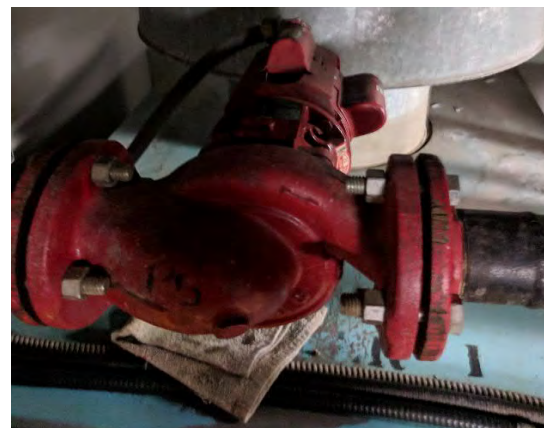
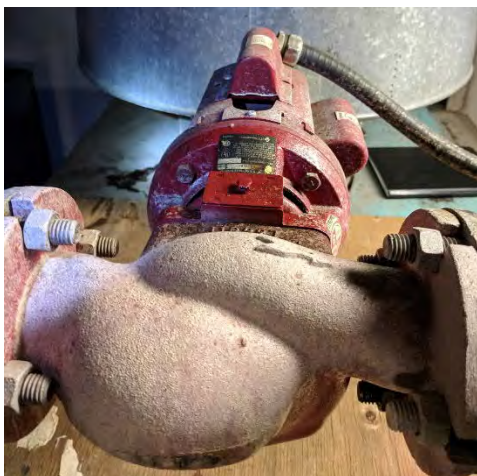
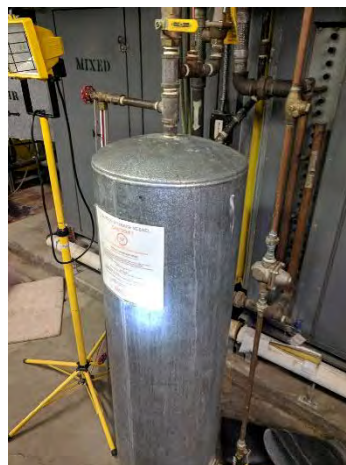
Figure 4-27 Typical B1/B2 Boiler

Figure 4-29 B1 Nameplate Model AAE-1080-N-M, Serial 88-AXG-3338

Figure 4-30 B2 Nameplate Model AAE-1080-N-M, Serial 88-AXG-3339

Figure 4-31 P1 and P2 System Pumps

Figure 4-32 P5 Boiler Pump

Figure 4-33 P6 Boiler Pump

Figure 4-34 Glycol Storage Tank

Original to building – Primary secondary boiler system. The boiler system including pumps, piping, and tanks are estimated to be 31 years old. Some pumps appear to have been replaced in the past but still appear to be old. P3 and P4 serving the air handler coils appears to have been replaced with a 3-way control valve.

- SuperHot Boilers and Armstrong pumps appears to be in poor but working condition.
- ASHRAE HVAC Applications 2015 service life estimates.
 - Boilers at 25 years.
 - Base mounted Pumps at 20 years.
 - Pipe mounted pumps at 10 years.
- The entire boiler system has exceeded its useful service life.
 - Higher efficiency boiler units and a redesign of the pumping system is highly recommended to meet current code and lower energy footprint at the same time.
- The burners on the boilers were noted to have been replaced in the past (date unknown).
- Immediate replacement of whole boiler plant is recommended.
 - Failure of the boiler system in winter will put the contents of the facility at risk.
 - To meet new code, higher efficiency boilers are recommended as a replacement at a minimum.

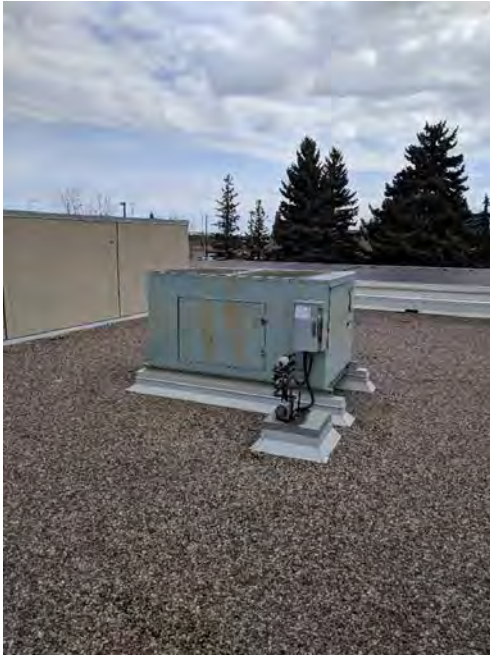
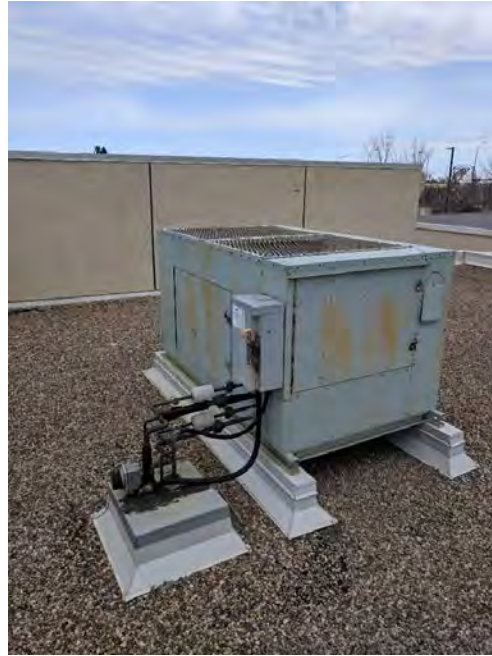
Figure 4-37 CH-1 on Roof

Figure 4-38 CH-1 on Roof

Original to building, equipment is considered to be 31 years old.

- 8 ton condensing unit was noted to still operate.
- Unknown make and model, no nameplate.
- ASHRAE HVAC Applications 2015 service life estimates.
 - Air cooled condensers at 20 years.
- Condensing unit has exceeded useful service life.
 - Cooling capacity was noted to be insufficient by operator.
 - Condensing unit performance may have degraded over time.
 - Condensing unit noted to contain R22 ozone depleting refrigerant.
- Immediate replacement of whole cooling system is recommended.
 - To meet new code, replacement of chiller should utilize new refrigerants and higher efficiency units.

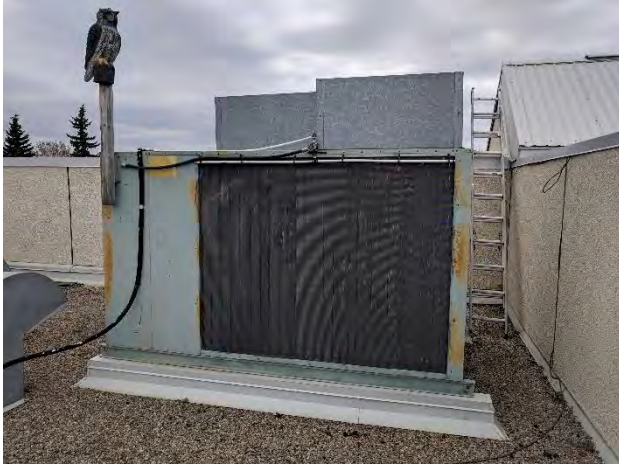
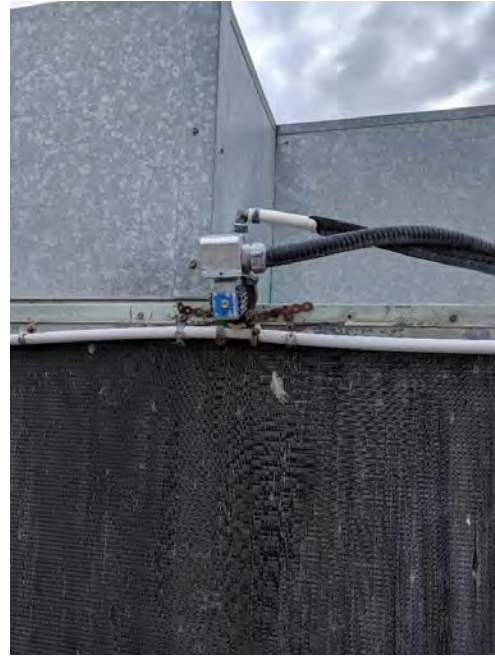
Figure 4-39 CH-2 on Roof

Figure 4-40 CH-2 Field Built Coil Water Cooling System

Original to building, equipment is considered to be 31 years old.

- 40 ton condensing unit was noted to still operate.
- Unknown make and model, no nameplate.
- ASHRAE HVAC Applications 2015 service life estimates.
 - Air cooled condensers at 20 years.
- Condensing unit has exceeded useful service life.
 - Cooling capacity was noted to be insufficient by operator.
 - Operator has noted that water must be fully running to meet load.
 - Condensing unit performance may have degraded over time.
 - Condensing unit noted to contain R22 ozone depleting refrigerant.
- Immediate replacement of whole cooling system is recommended.
 - To meet new code, replacement of chiller should utilize new refrigerants and higher efficiency units.

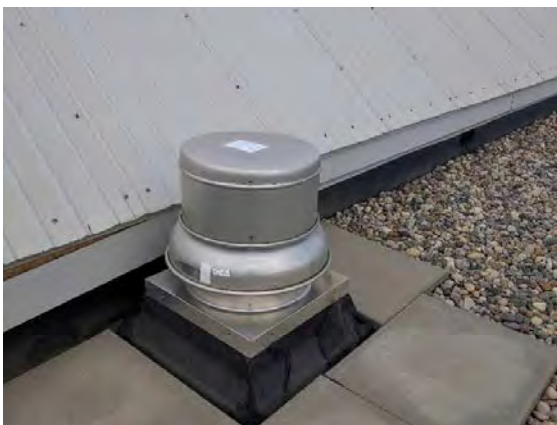
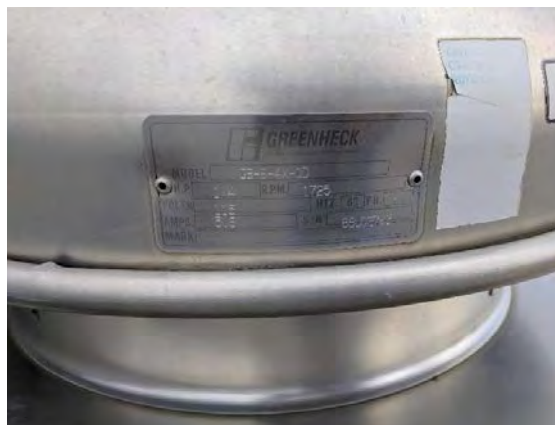
Figure 4-41 EF-1 on Roof

Figure 4-42 EF-1 Serial Number 88J02793

Original to building, equipment is considered to be 31 years old.

- Greenheck Exhaust fan appears to be in fair working order.
- Exhaust fan control switch located in vestibule to Men's Washroom.
- ASHRAE HVAC Applications 2015 service life estimates.
 - Ventilating roof exhaust at 20 years.
- No noted operating problems.
- High priority replacement of the exhaust fan is recommended.

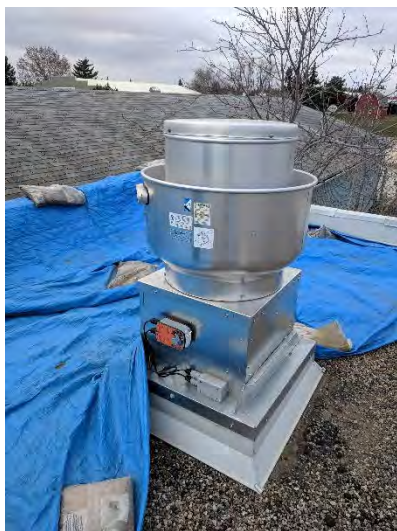
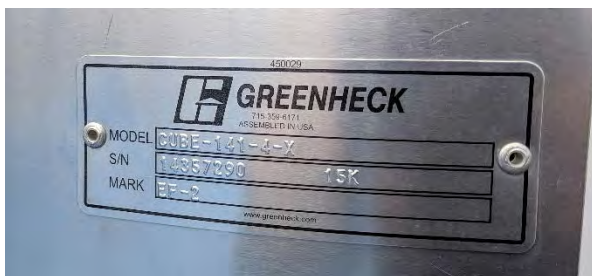
Figure 4-43 EF-2 on Roof

Figure 4-44 EF-2 Serial Number 14357290

New to building, equipment is installed at the same time as MUA-1.

- Greenheck Exhaust fan appears to be in good working order.
- Exhaust fan was operating at time of visit.
- ASHRAE HVAC Applications 2015 service life estimates.
 - Ventilating roof exhaust at 20 years.
- No noted operating problems.
- Low replacement priority.

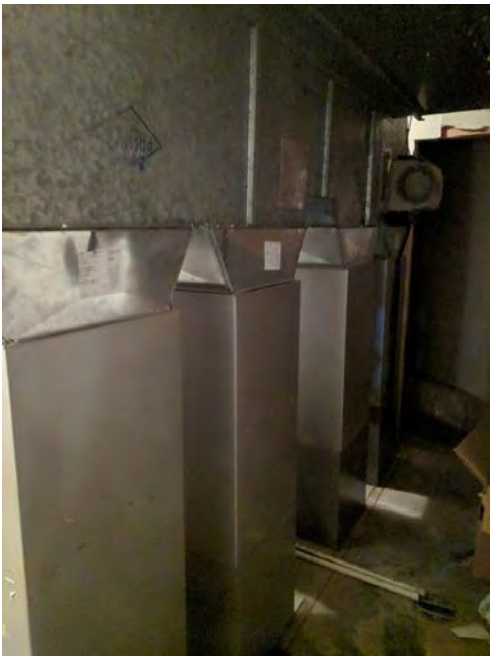
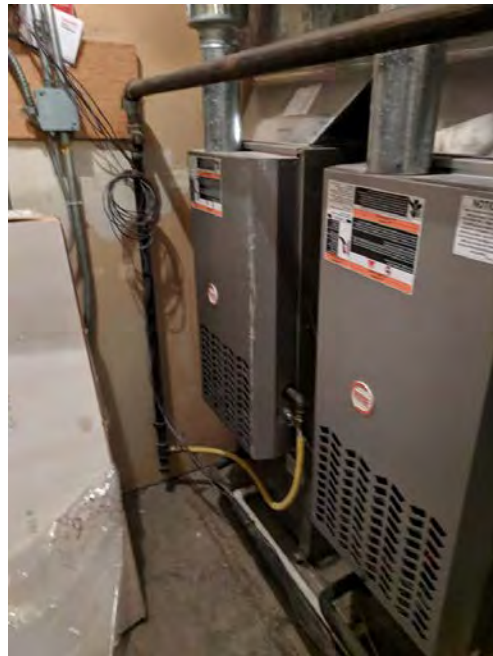
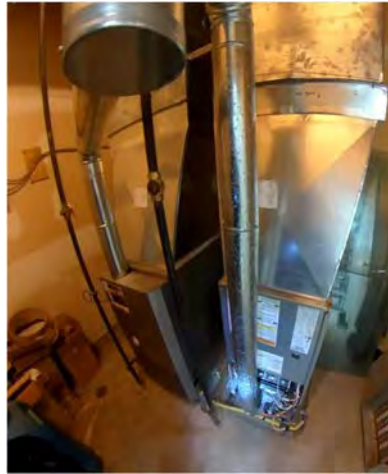
Figure 4-45 Fuchs and OTS Backside of Furnaces (Four Downdraft Furnaces with Humidifier in Back)

Figure 4-46 Typical Payne Downdraft Furnace Found in OTS Mechanical Room

Figure 4-47 Richard Larson Mechanical Room with Payne Furnaces (Two Downdraft Furnaces)

The furnaces are relatively new compared to the building. These were noted to have been replaced around 8-9 years ago as mentioned by the operations team.

- All Payne furnaces are noted to be in good working order.
- Operator has expressed that these furnaces are good and does not cause any trouble.
- ASHRAE HVAC Applications 2015 service life estimates.
 - Gas furnaces at 18 years.
- No noted operating problems.
- Medium replacement priority.

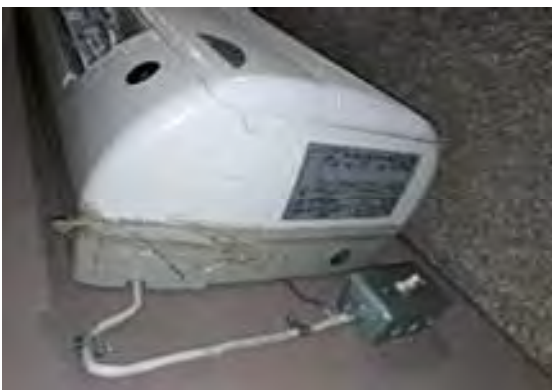
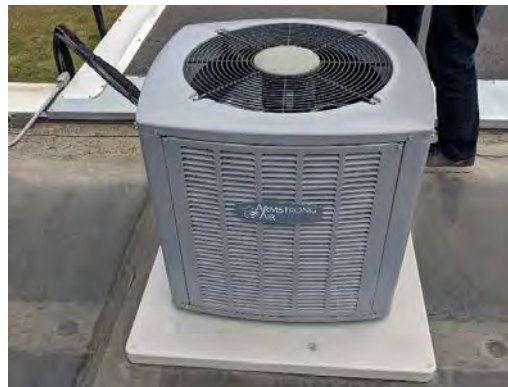
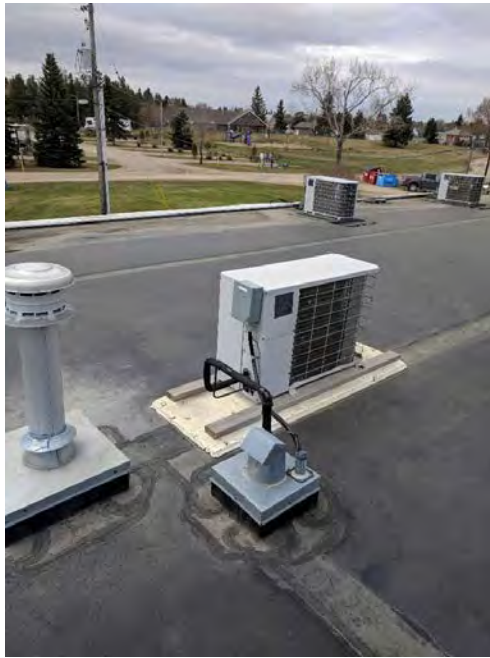
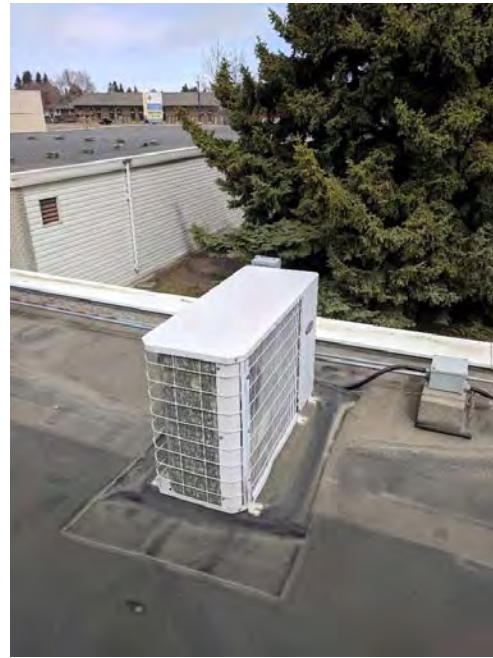
Figure 4-48 Typical Indoor Unit in OTS

Figure 4-49 Newer Condensing Unit Serving the OTS Extension

Figure 4-50 Condensing Unit Serving the Residential Portion of OTS

Figure 4-51 Typical Condensing Unit Near Edge of Building (not used anymore)

Majority of condensing unit and indoor units are original to the building.

- Five of the existing United Technologies Carrier A/C split units in the OTS building is no longer being used.
 - New split AC coil and condensers were added to the OTS furnaces to address cooling issues.
- ASHRAE HVAC Applications 2015 service life estimates.
 - Split DX at 15 years.
- The original units should be disposed of as they contain R-22 ozone depleting refrigerant.
 - The existing ac units drain condensate through the exterior wall right behind each indoor unit, the exterior wall will have to be repaired when the units are removed.
- Removal of split units recommended.
- Low Priority.

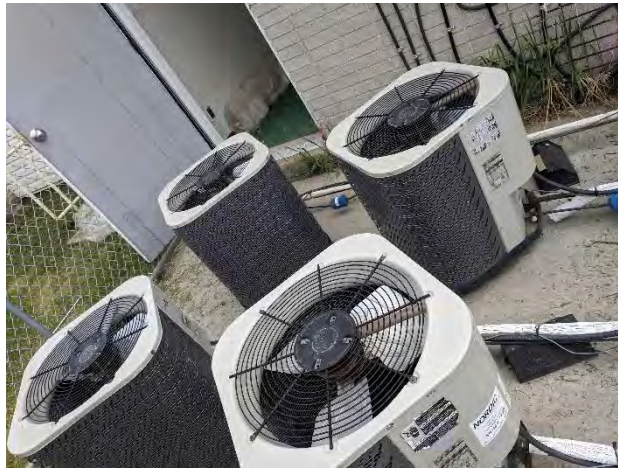
Figure 4-52 New OTS Outdoor Units (4 Units)

New OTS outdoor condensing units are installed in the last 10 years.

- No noted problems noted by operator.
- ASHRAE HVAC Applications 2015 service life estimates.
 - Split DX at 15 years.
- AC units appear to be in good working condition.
- AC units are estimated to be 9 years old.
- Medium Priority for replacement.

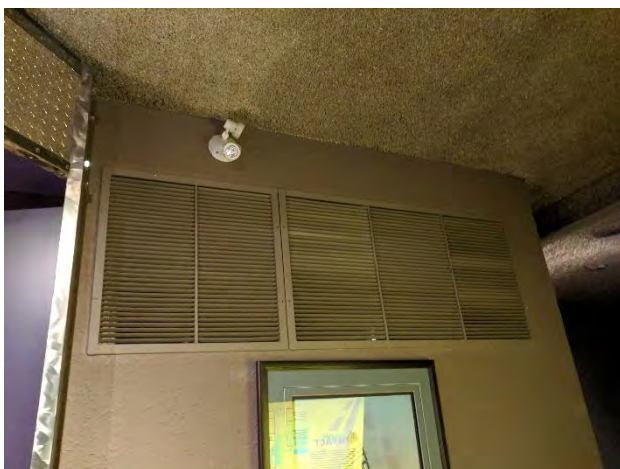
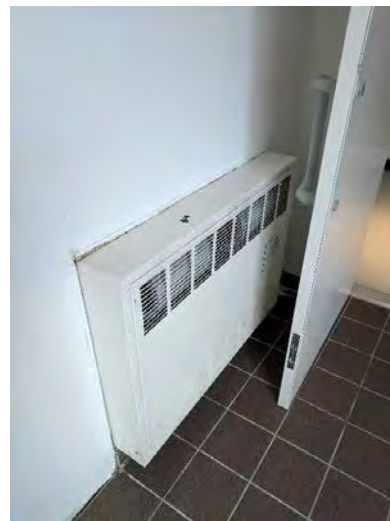
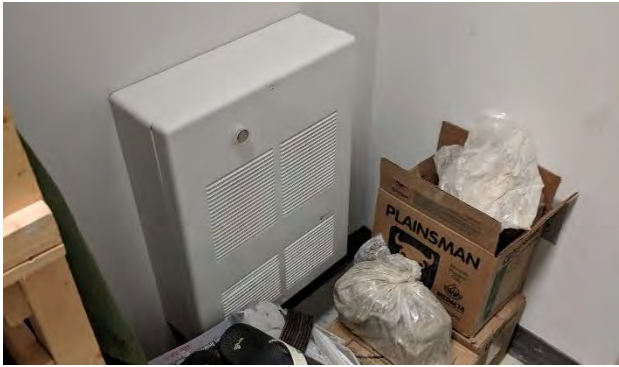
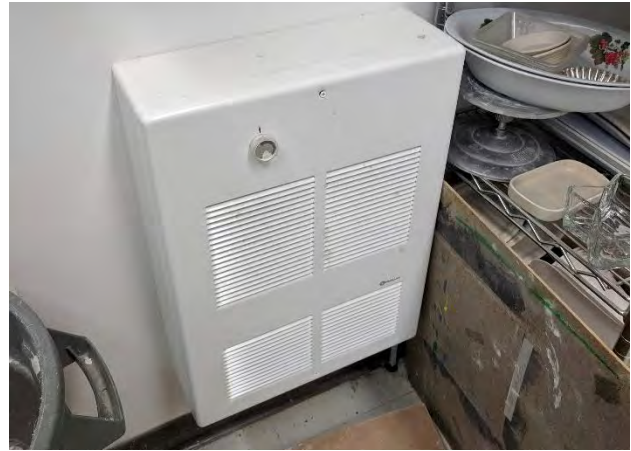
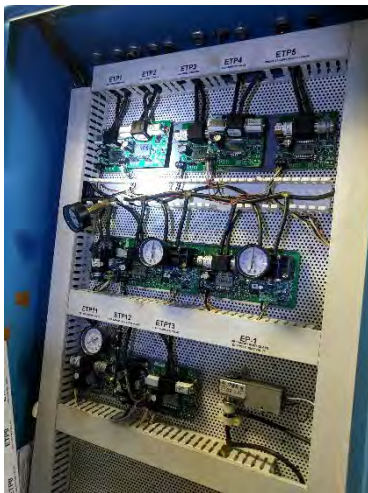
Figure 4-53 Return Grilles in OTS/Fuchs

Figure 4-54 Original Cabinet Unit Heater in Corridor to Fuchs

Figure 4-55 Electric Unit Heater in Pottery Closet

Figure 4-56 Electric Unit Heater in Kiln Room

Figure 4-57 Pneumatic to Digital Control Panel

- ASHRAE HVAC Applications 2015 service life estimates.
 - Electric unit heaters at 13 years.
 - Hot water unit heaters at 20 years.
 - Pneumatic controls at 20 years.
- Diffusers and grilles appear to be in fair working order, no replacement recommended.
- Electric heaters in pottery closet and kiln room was tested at time of visit and appear to work. Equipment is estimated to be 9 years old. Medium priority for replacement.
- Hot water heaters in corridor and pottery area vestibule was tested at time of visit and appears to work. Equipment is estimated to be original. High priority replacement.
- All electronic control system upgrade, phasing out of pneumatic system is recommended. High priority replacement.

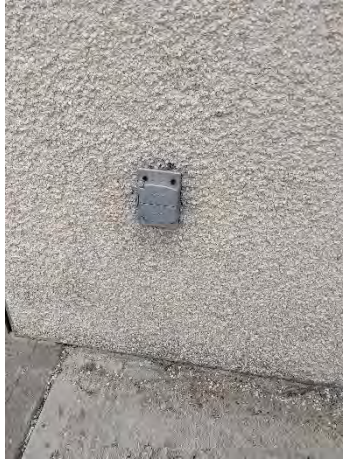
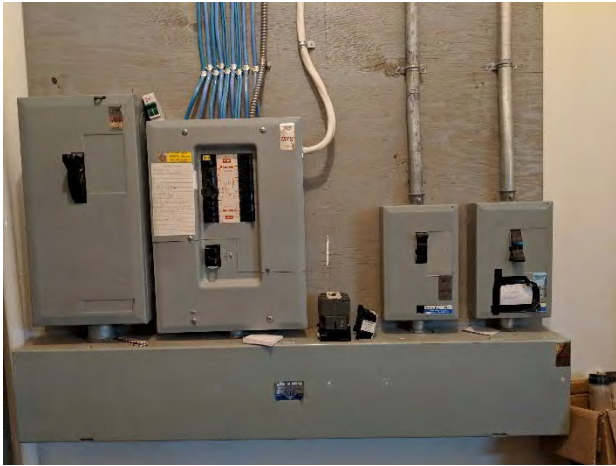
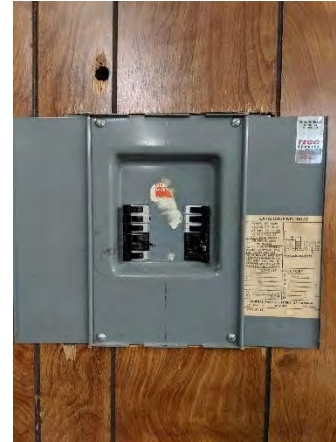
Figure 5-3 West Wing Main Distribution

The 120/240V distribution appears to be in working order, though they were not tested for functionality. The main utility power feeds a 200A 120/240V single phase disconnect which then feeds a splitter. The splitter subfeeds two 120/240V panels, which are both located in the West Wing. The most recent renovations appear to be in 1980, therefore the equipment is more than 30 years old. A rule of thumb for breaker end of life is 30 years with regular maintenance. Once equipment has reached their approximate end of life, the probability of failure increases with time. For example, after 30 years, approximately one out of 20 breakers may not function as intended. With proper maintenance, the electrical distribution equipment may remain operational for the next 10 years, but it is recommended to replace the main electrical distribution equipment (panels, disconnects, splitter, etc.) within the next five years. The existing cables can remain in place and be re-used as long as they are sized properly as per CEC.

Figure 5-4 West Wing Main Distribution

Figure 5-5 West Wing Panel A

However, it was mentioned that it is intended for Richard Larson Wing to be completely removed. If this is completed, no electrical upgrades will be required.

If the West Wing is not demolished, the utility fed should be removed and the main disconnect fed from the main building switchboard.

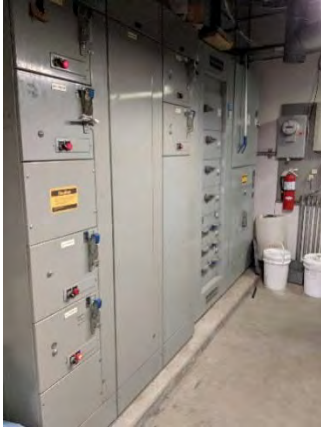
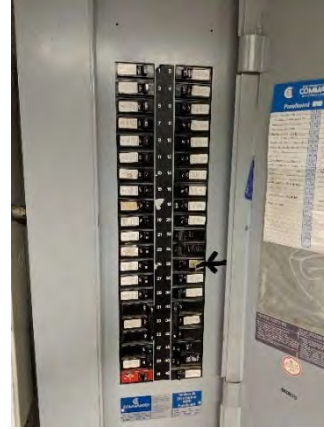
During discussion with the head electrician, it was noted that the MCC has two faulty disconnects and do not function as per Code. The main switchboard and MCC are the brand name "Commander", which doesn't exist anymore and replacement parts are difficult to come by. As this equipment is already failing, it is highly recommended the MCC and switchboard be replaced immediately. It was also noted that one of the phases from the utility drops occasionally resulting in starter coils to burn out prematurely, further investigation is required to confirm the reasoning for the phase dropping. For the new MCC replacement, phase loss relays should be considered in the design. The existing cables can remain in place and be re-used as long as they are sized properly as per CEC.

Figure 5-6 MCC and Main Distribution (Main Museum)

Figure 5-7 Panel D

The existing 120/208V panels appear original and are of the brand name “Commander”. Presently, they are nearing their end of life. The head electrician noted that the bus in Panel D had failed and needed to be replaced. There is a high risk this issue will happen to the remaining panels. Since the panel manufacturer does not exist and replacement parts are difficult to come by, it is highly recommended all the 120/208V panels be replaced. The existing cables can remain in place and be re-used as long as they are sized properly as per CEC.

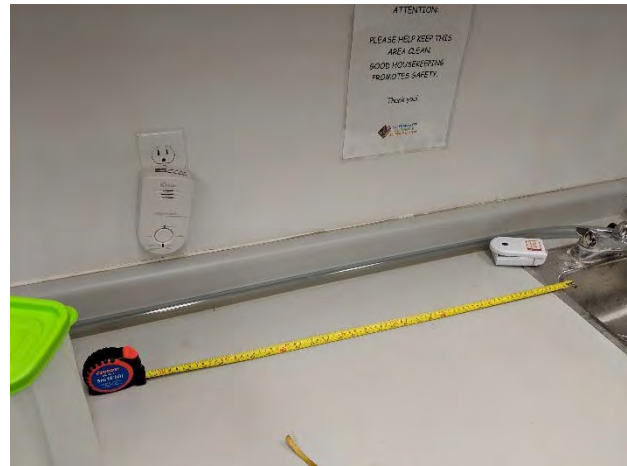
Receptacles located within 1.5 m of a sink must have GFI protection, currently none of the receptacles within 1.5 m have GFI protection. It is recommended to replace these receptacles with GFI type receptacles.

Figure 5-9 Receptacles Without GFI Protection

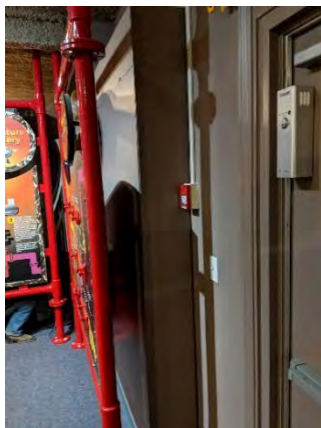
The existing main disconnect for the incoming service was unable to be accessed as it was located behind a floor-mounted display. Currently, this does not meet Section 2-308 of the CEC, a minimum of 1 m working space must be provided and maintained in front of electrical equipment. The existing must be moved further away from the cabinet to meet Code.

Figure 5-10 No Access to Main Disconnect for East Wing

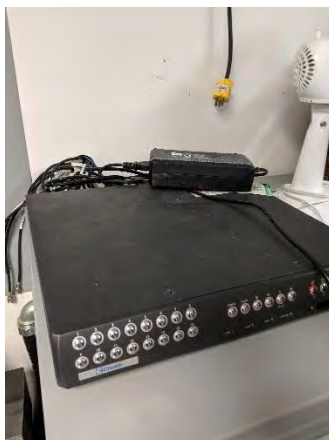
An existing ADT security system is installed with motion detectors located in common areas. Door contacts appear to be in place, but not on all doors. There are cameras located throughout, however, the main recording device has been disconnected. Currently, there is not an active camera in the facility. Building security is not a Code requirement; therefore, this is up to the client if it should be replaced. However, as the facility houses valuable items, it is recommended a proper security system is installed.

Figure 5-12 Disconnected Camera Recorder

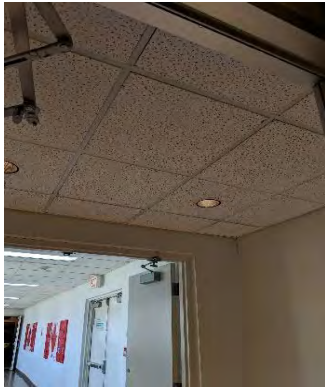
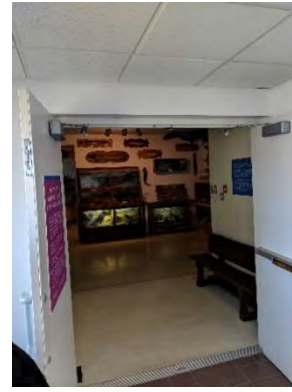
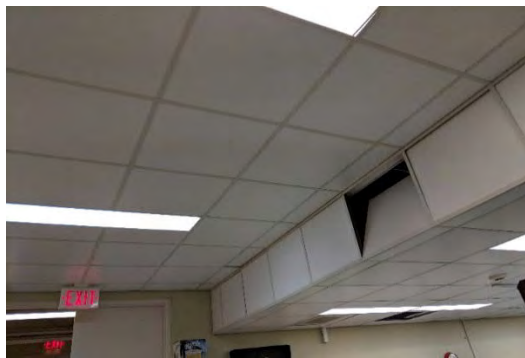
- Add one additional smoke detector above “storage room” in Gallery.
- Add one additional smoke detector higher ceiling area of employee lunchroom.
- No smoke detector in vestibule leading to East Wing corridor.
- No magnetic hold open devices are installed on doors in corridor leading to east wing. Currently, they are mechanically held open. If they are intended to be fire-rated doors and want to be kept open, they will require magnetic hold open devices and a smoke detector on either side of the doorway. The hold open devices and smoke detectors would need to be connected to the fire alarm system. However, If the doors are kept closed and aren’t held open mechanically, this meets the intent of the code, but users will have to manually open the doors.

Figure 5-13 Vestibule Missing Smoke Detector

Figure 5-14 Corridor Doors Mechanically Held Open

Figure 5-15 Missing Smoke Detector Higher Ceiling Area

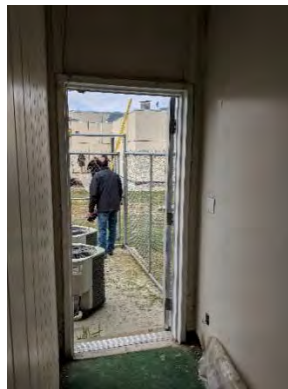
- No magnetic hold open devices are installed on door between Fuchs and OTS Building. Currently, it is mechanically held open. If it is intended to be a fire-rated door and to be kept open, it will require a magnetic hold open device and a smoke detector on either side of the doorway. The hold open device and smoke detectors would need to be connected to the fire alarm system. However, If the door is kept closed and isn't held open mechanically, this meets the intent of the code, but users will have to manually open the door.
- Exit door from Mechanical Room does not have a pull station in place.

Figure 5-16 Mechanical Room Exit Door Missing Pull Station
