LCSC Visitor Experience Report

Lloydminster Cultural and Science Centre Condition Assessment

Associated Engineering Alberta Ltd. (AE) carried out a visual review and condition assessment of the Lloydminster Cultural and Science Centre on May 8, 2019.

Lloydminster Cultural and Science Centre Condition Assessment (Architecture)

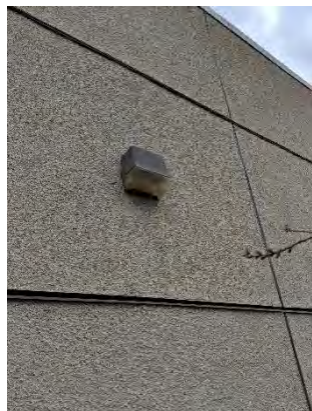
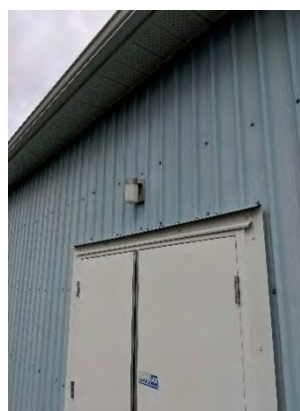
As the site was visited during the day, all exterior lights were off and unable to be confirmed if in working order. Lights appear original and are old, aged, broken and in need of replacement. In discussion with maintenance staff, multiple areas are lowly lit, such as the entrance and rear, additional lighting should be installed. Lights fixture above exit doorways should be replaced with new LED fixtures to provide adequate lighting. Currently, the exterior lights are controlled by a time clock and photocell. Upgrading the exterior lighting to LED will also provide cost savings and reduce long term maintenance costs.

Figure 5-19 Exterior Lighting

Figure 5-20 Exterior Lighting

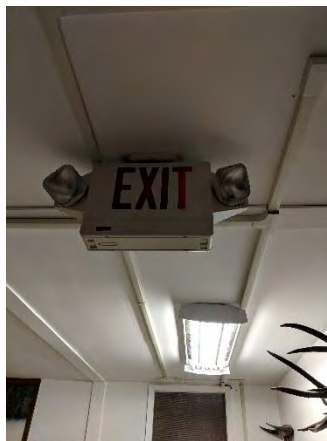
Not every exit has an exit sign installed as per ABC section 3.4.5 “Exit Signs”. Some of the existing exit signs are not lit or are barely lit, which does not meet Code requirements. The existing exit signs can remain as is, but if the building is renovated the updated green “running man” (pictogram) style signs will be required as per ABC Section 3.4.5. Testing should be completed to ensure exit signs illuminate in the event of a power outage.

Figure 5-21 Exit Sign Barely Lit

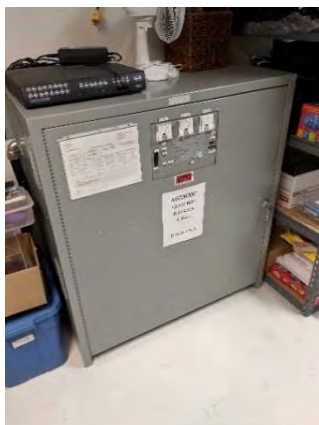
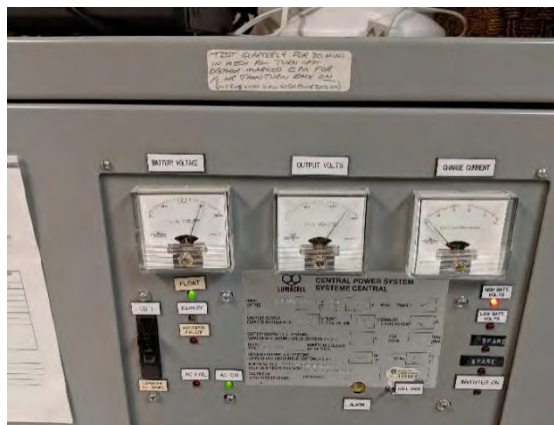
The majority of emergency lights and exit lights are provided emergency power from a DC inverter located in the Storage Room by the Main Office. Currently, the DC inverter was last serviced in 2002. In discussion with the electrician, this is an item that requires a special tech for service and parts are not readily available. It is recommended to remove the DC inverter and replace existing exit lights with built in emergency lighting and battery pack.

Figure 5-22 DC Inverter

Figure 5-23 DC Inverter

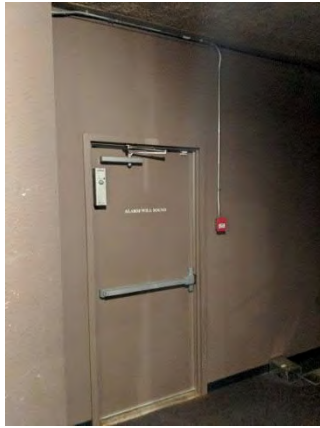
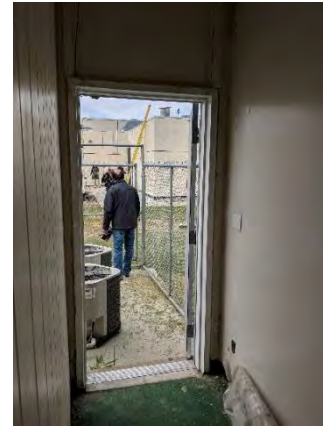
- Mechanical Room does not have Exit sign by door.
- Mechanical Room does not have emergency lighting in place.
- West Exit door does not have an Exit sign or emergency lighting.

Figure 5-24 Missing Exit Sign

Figure 5-25 Missing Exit Sign

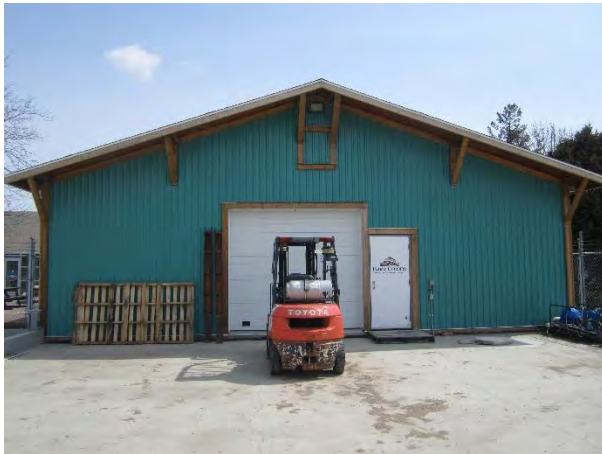
FIGURE 1- New Richard Larson West Wall

With the demolition of the other parts of the Richard Larson Building a new wood frame west wall for the East Wing was constructed with green corrugated metal cladding, insulation of unknown type and interior painted particle board finish. See Figure 1.

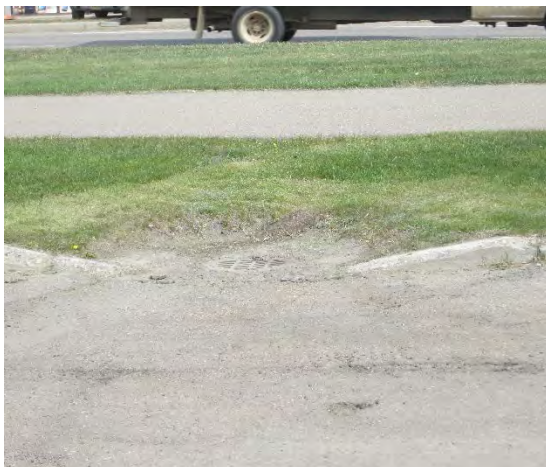
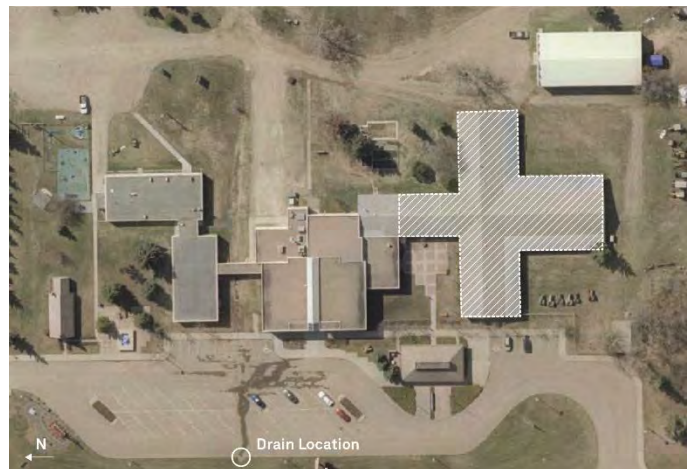
FIGURE 2 - Single Drain in Parking Lot for entire NE Site Area

- The flooding since 2010 has indicated multiple site and building vulnerabilities to water ingress in the case of floods. With the demolition of the other parts of the Richard Larson Building a new drain and sump pump has been added immediately west of the new wall at the west end of the remaining East Wing of the Richard Larson Building. Despite this, floodwaters have come close to the threshold of the west door of the East Wing. In addition, it was noted during the 2019 site visit that there was only a single drain location at the north edge of the central parking lot. This single drain serves virtually the whole NE corner of the site and is inadequate. See Figure 2.

Accordingly, flooding must be considered a substantial risk to all of the existing LCSC buildings.

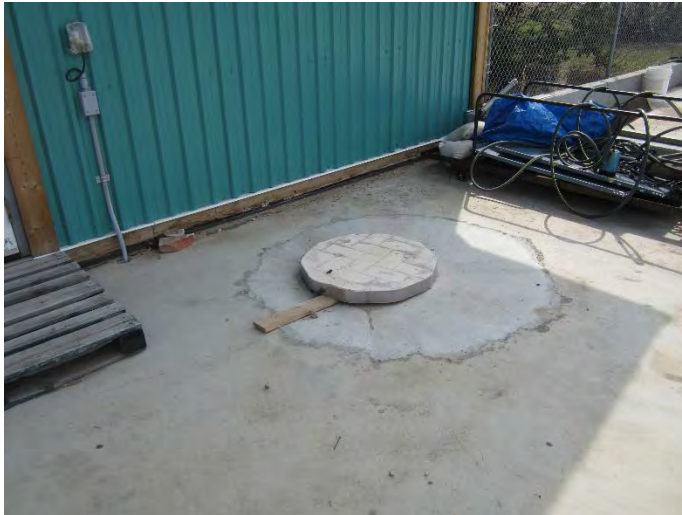
FIGURE 3 - New Sump Cover East of Richard Larson Remnant

- Since 2010 the East Wing, the only remaining component of the Richard Larson Building, has exhibited further deterioration, with the exception of the new east wall. Further investment in this building is not recommended, except as minimally necessary to protect items stored there.

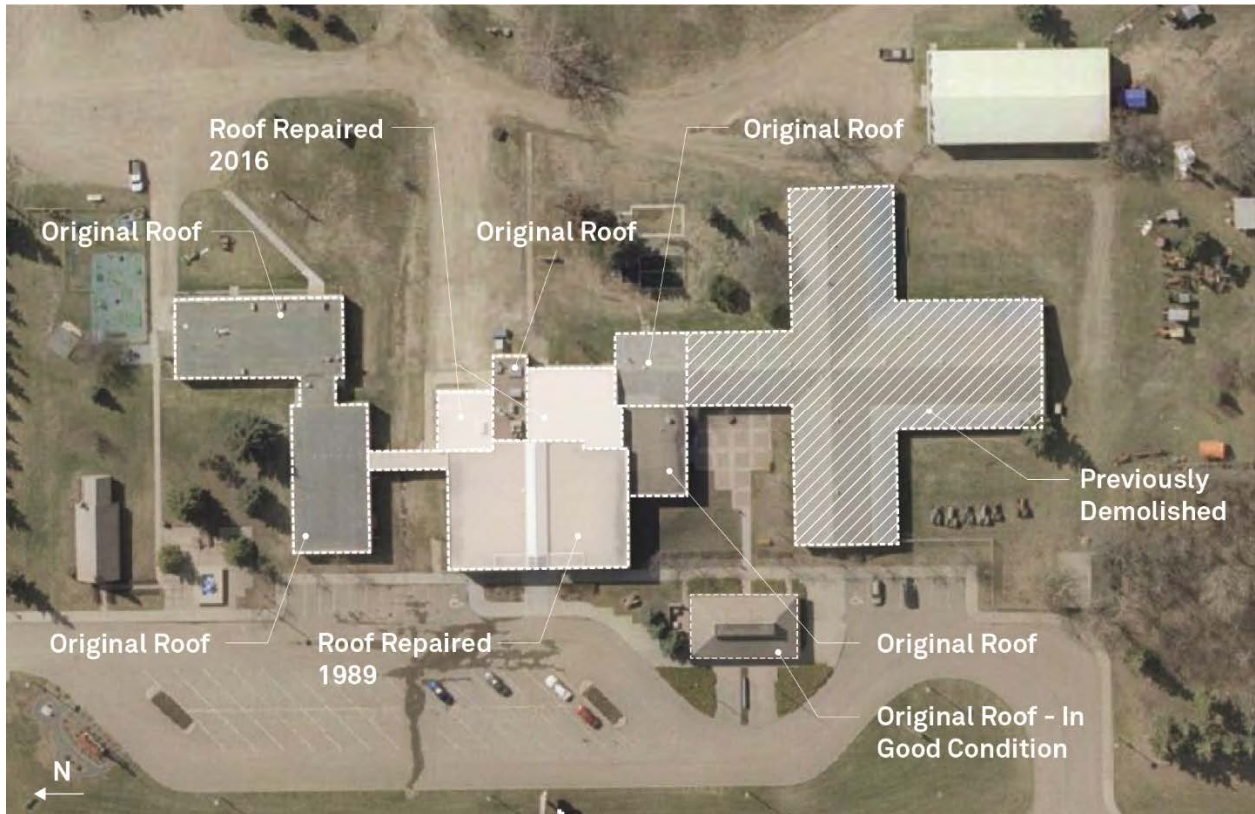
FIGURE 5 - Roof Repairs

- The roof of the complex has been selectively repaired. See Figure 5: Roof Repairs.
- Additional roof repairs will be required shortly to avoid further leakage.

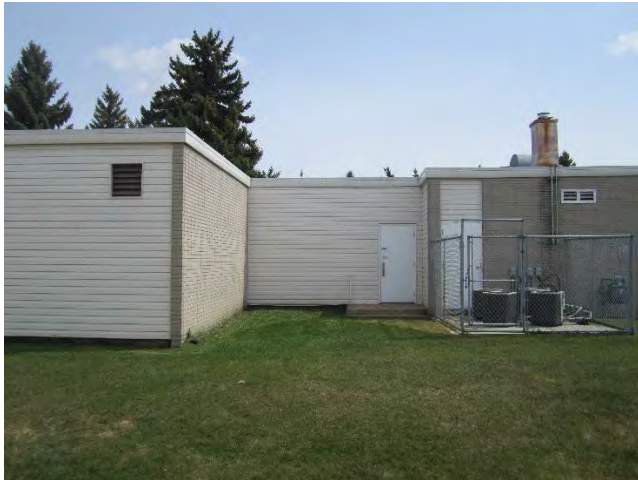
FIGURE 8 – Fuchs Gallery Exterior West Side

- Since 2010 the 1963 Fuchs Wildlife Exhibit building has exhibited further deterioration. The building is now very aesthetically outdated. See Figure 8.
- The Fuchs gallery ceiling was tested for asbestos in 2017 and asbestos was identified.
- Selective air quality testing indicated localized and non-hazardous mould.
- The corridor to the Fuchs building is a location of one of the major post 2010 roof leaks.
- Further investment in these buildings is not recommended, except as minimally necessary to protect exhibits.

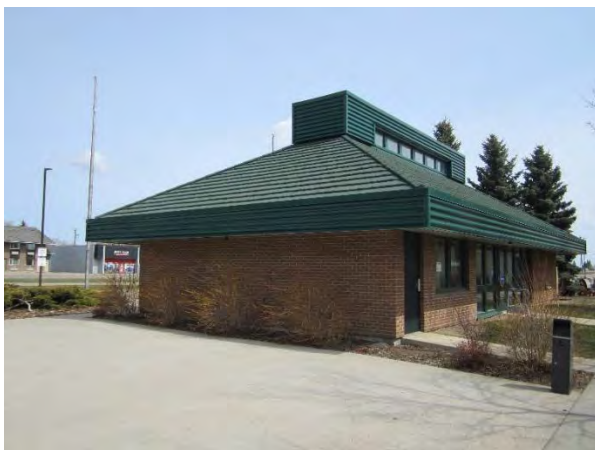
FIGURE 9 - Studio 2 Building Exterior

1. Overall interior and exterior finishes appear to be well maintained and good condition. See Figures 9 and 10.
2. Currently requires minimal maintenance.
3. Building has a 4' crawl space with no visible moisture problems.
